# Appendix F

Photographic Collection from 2013 and 2014 Site Investigations

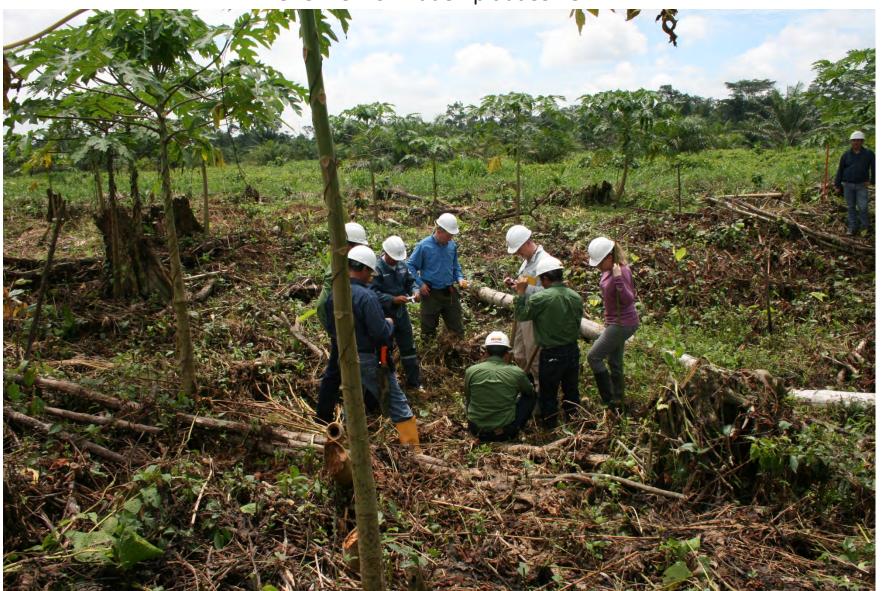
Photo 1 Overview of hidden pit at SSF-34

Crude at an undocumented pit at SSF-34. Photoionization detector (PID) measurement of volatile organic vapors emanating from oil is 46.5 ppm

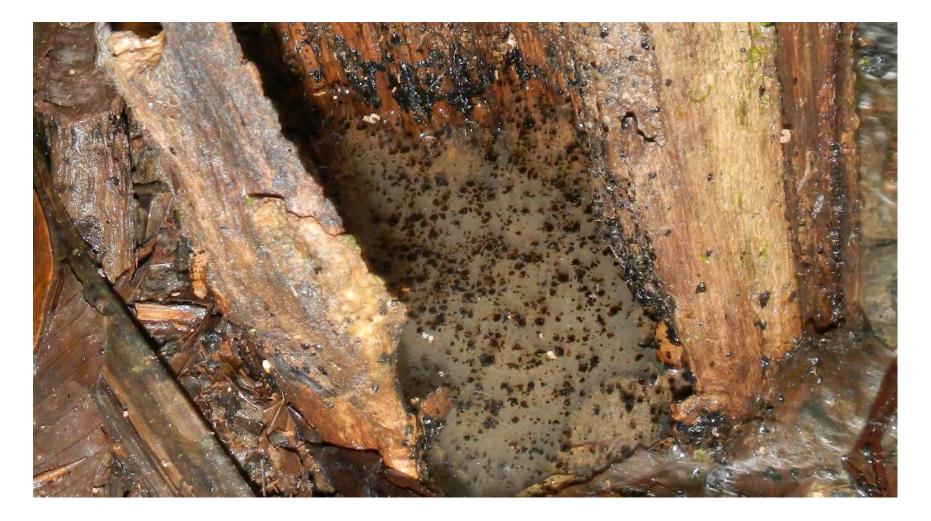
### Photo 10 AG-06

Oil droplets in water that had collected in a tree stump in AG-06 wetland.

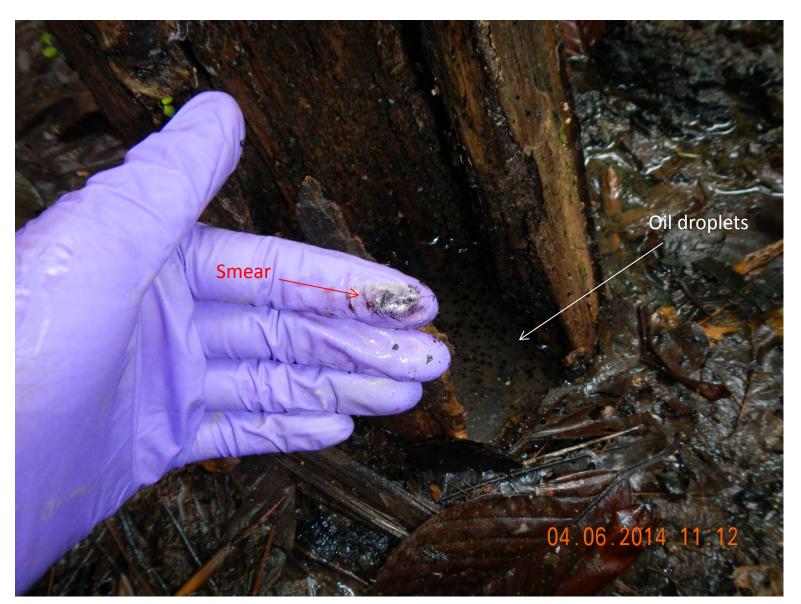
Smear of crude oil from inside stump where oil droplets were observed at AG-06

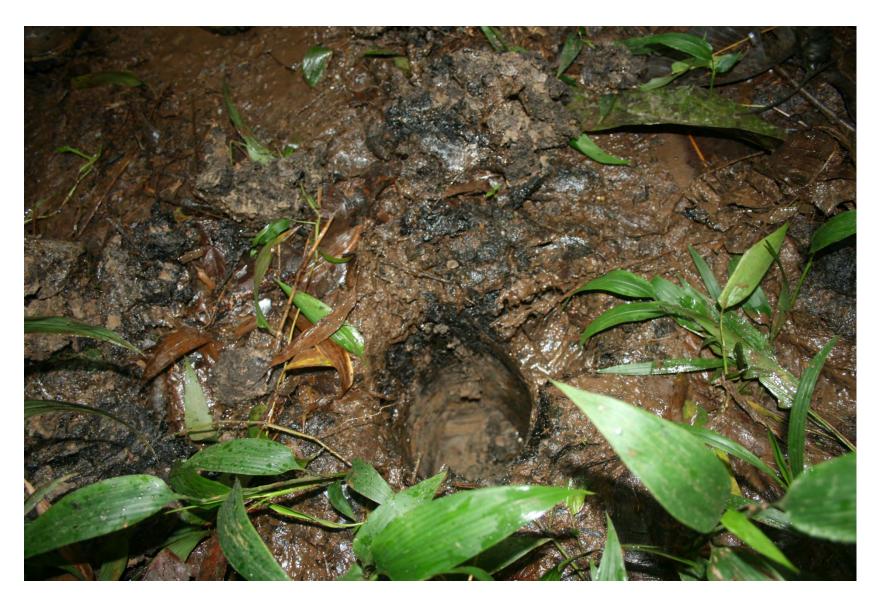
# Photo 17 Oil contaminated soil beneath leaf litter at AG-06

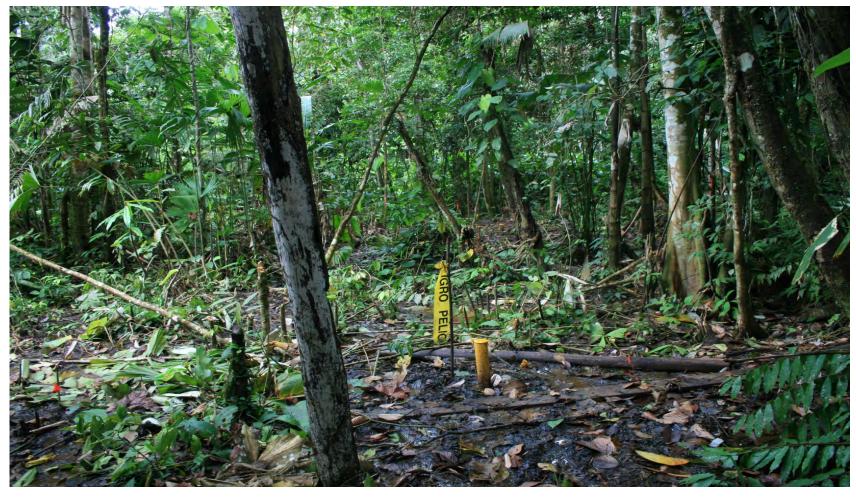
AG-06

Contaminated wetland with LBG's monitoring well (yellow tube). The monitoring wells in the wetland discovered elevated levels of petroleum up to **twelve times** higher than Ecuadorian regulations permit. LBG's sampling also found napthenic acids present in the groundwater. Napthenic acids are components of crude oil that are soluble in water — their presence means there is crude in the water itself not from any sediment or soil particles in the water.

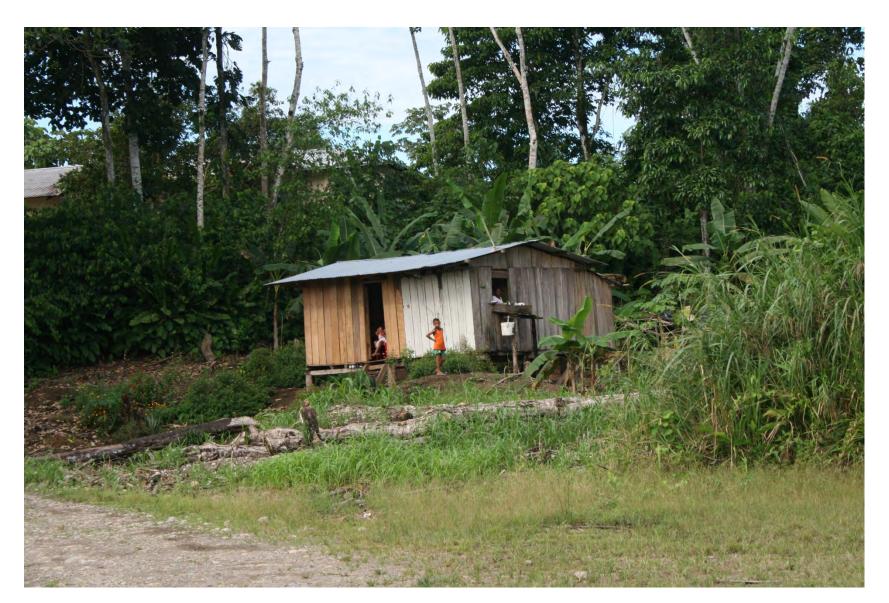
# House and residents next to hand dug water supply well at LA-16

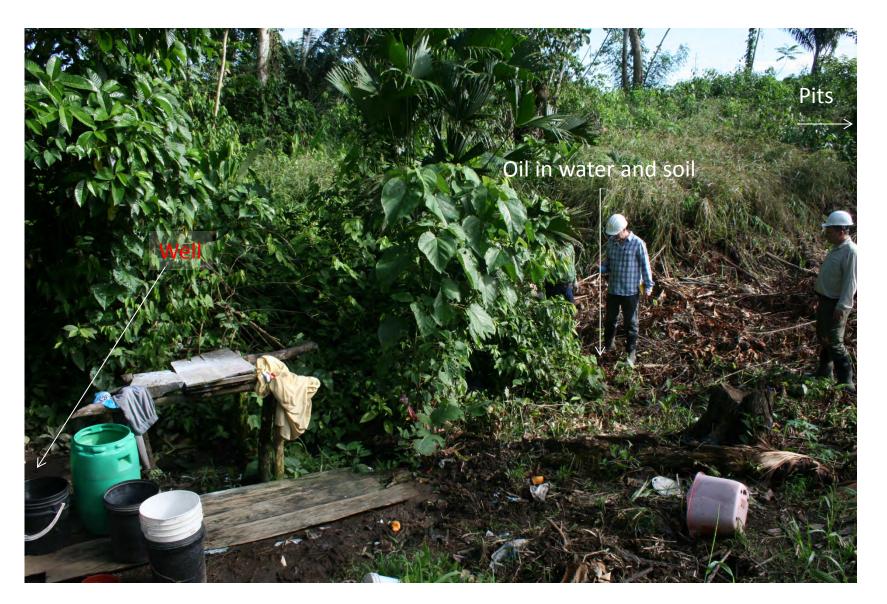
Location where petroleum evident in soil and water next to hand dug well at LA-16

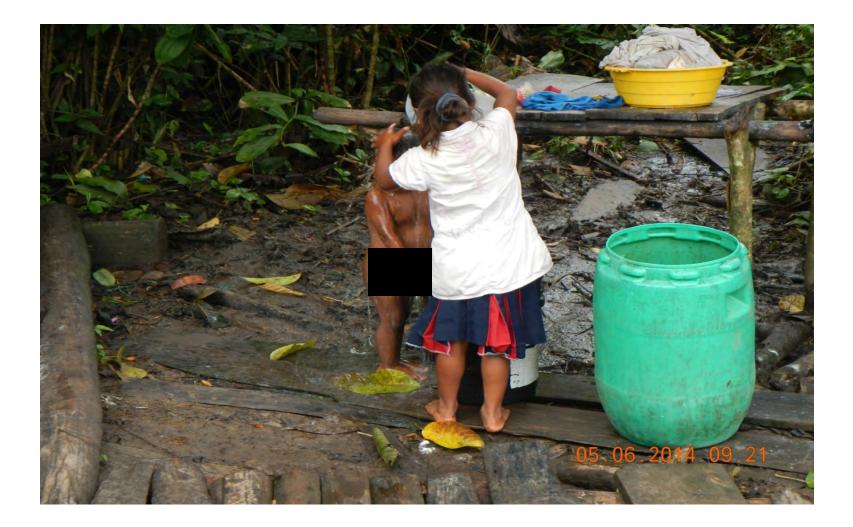
### LA-16

Girl bathing her little brother from water from a domestic well at LA-16. Napthenic acids were found present in this domestic well, indicating the presence of crude oil in the water.

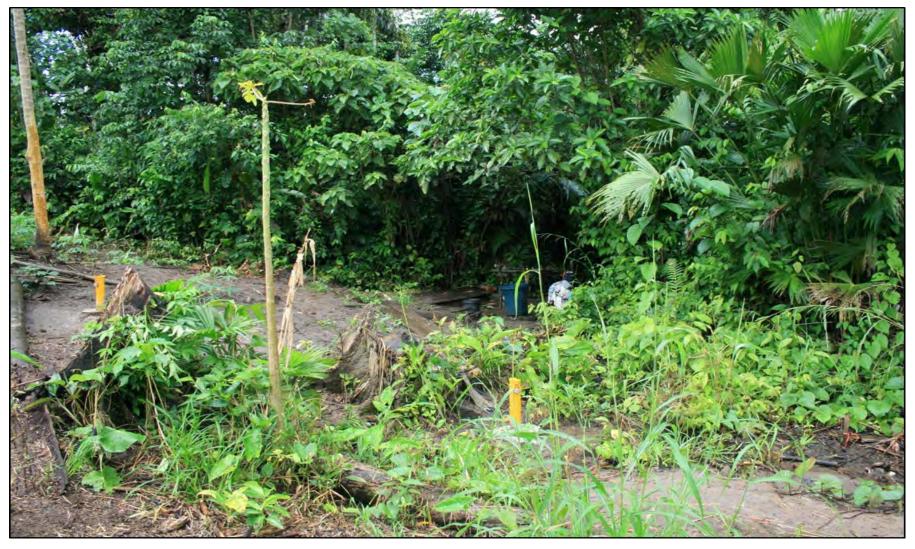
### LA-16

Area downgradient from TexPet pits with domestic water well in the background. In the foreground are two LBG monitoring wells (yellow pipes). LBG found groundwater contamination **four times** the Ecuadorian regulations.

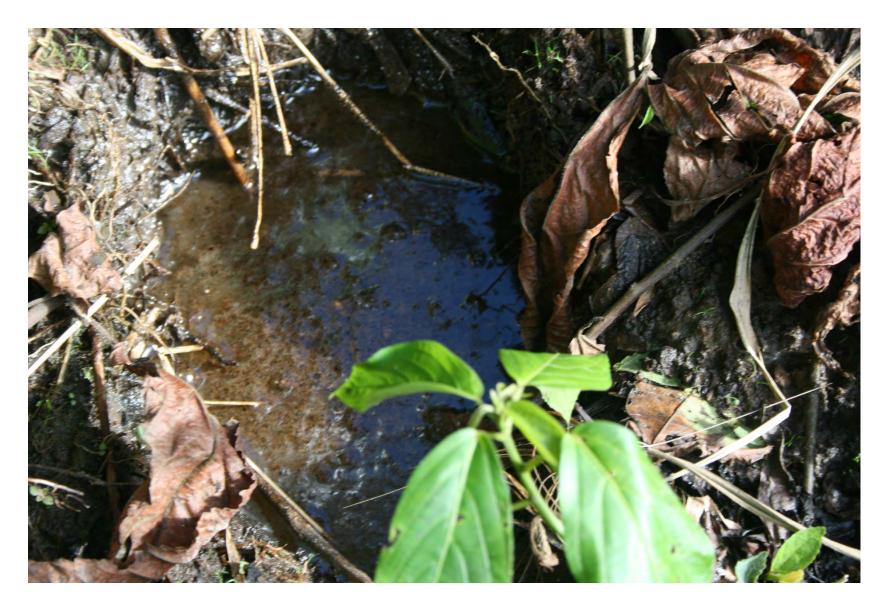
Oil in soil and water next to hand dug well at LA-16 (location shown in Photo 22)

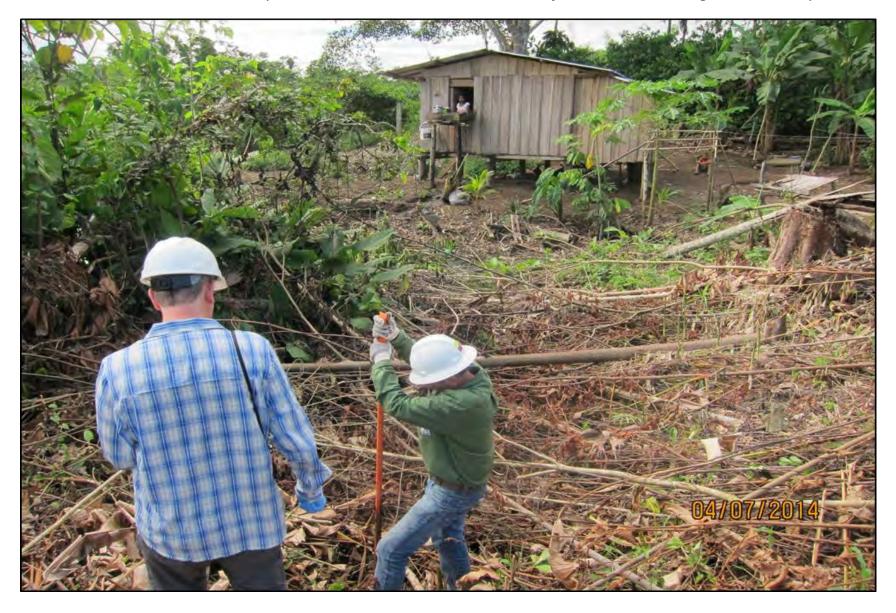
#### LA-16

Cleared cornfield that is east of two TexPet pits. PetroEcuador employee is using a digging bar to visually examine the soil as local residents look on. Samples collected in this area were **twenty-five times** the Judgment clean-up standard.

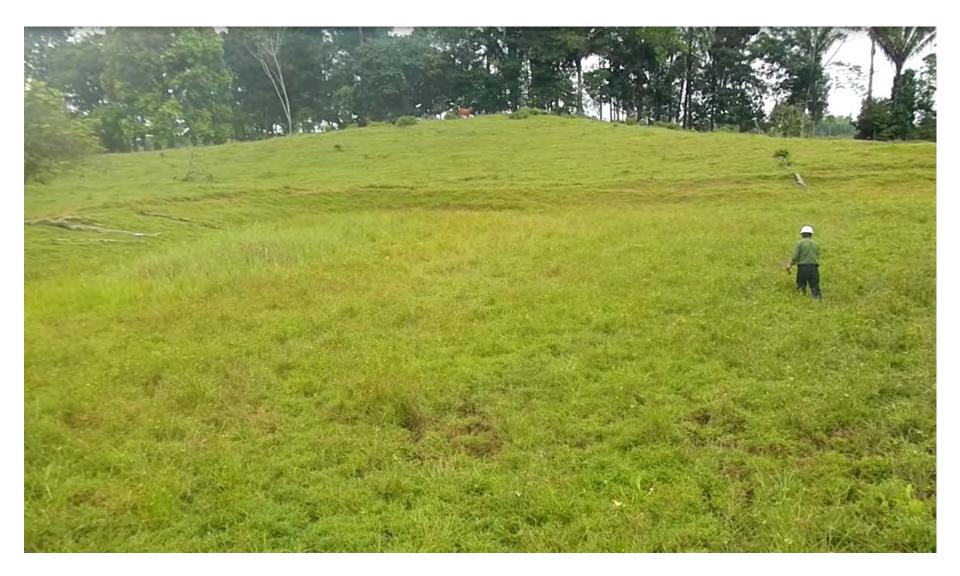
# Photo 30 Pit 3 at SSF-13

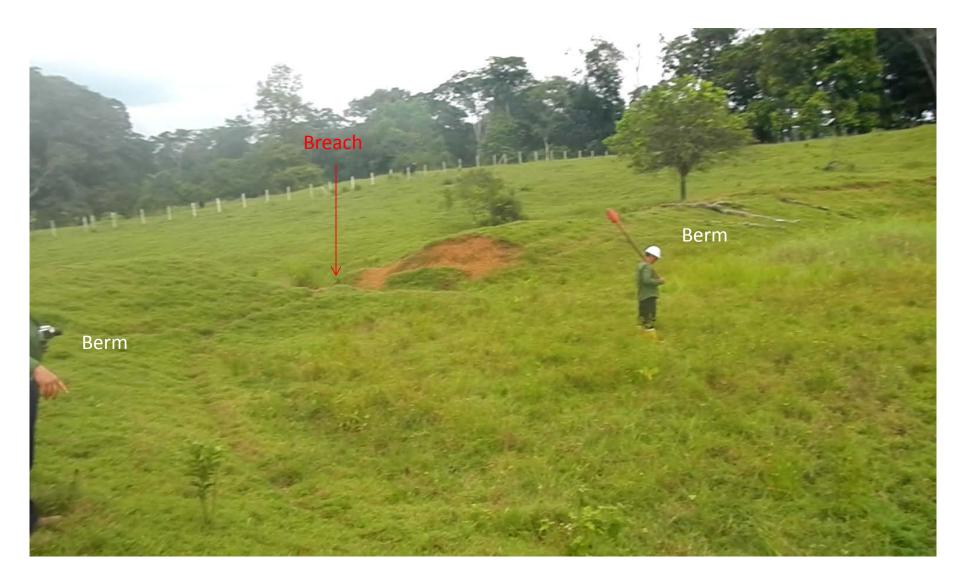
Photo 31 Breach in pit berm at Pit 3 at SSF-13

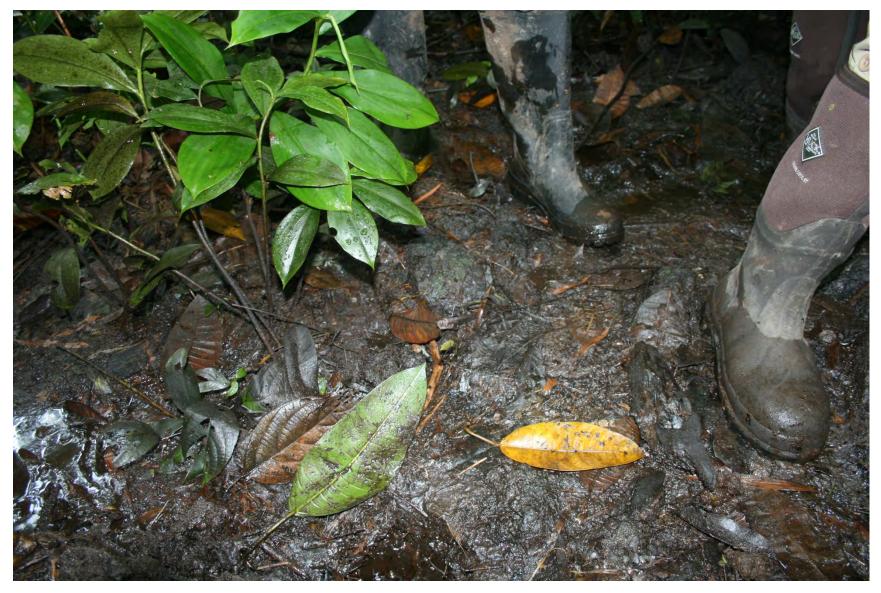
Photo 34 Oil sheen on sediment at LA-02

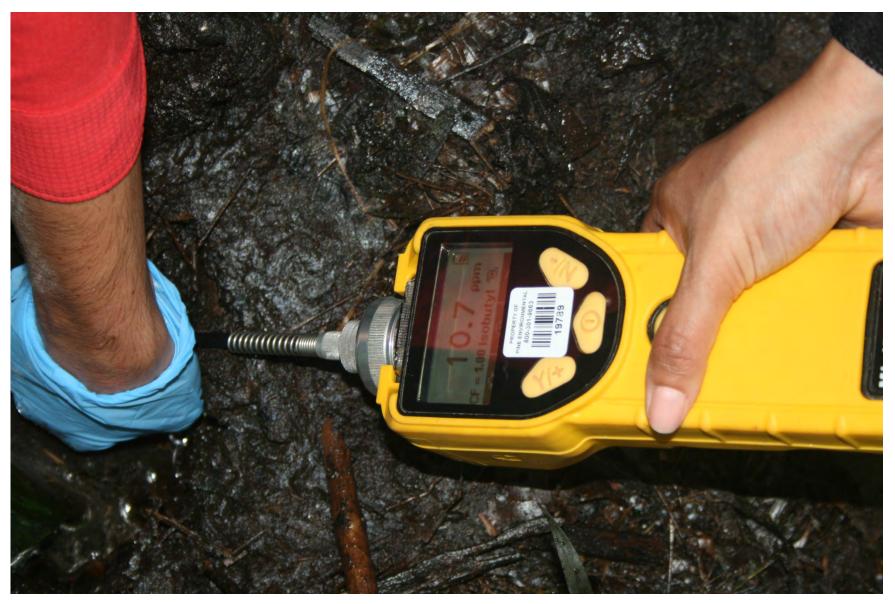
Oil sheen on sediment and groundwater seep at LA-02 with PID reading (10.7 ppm)

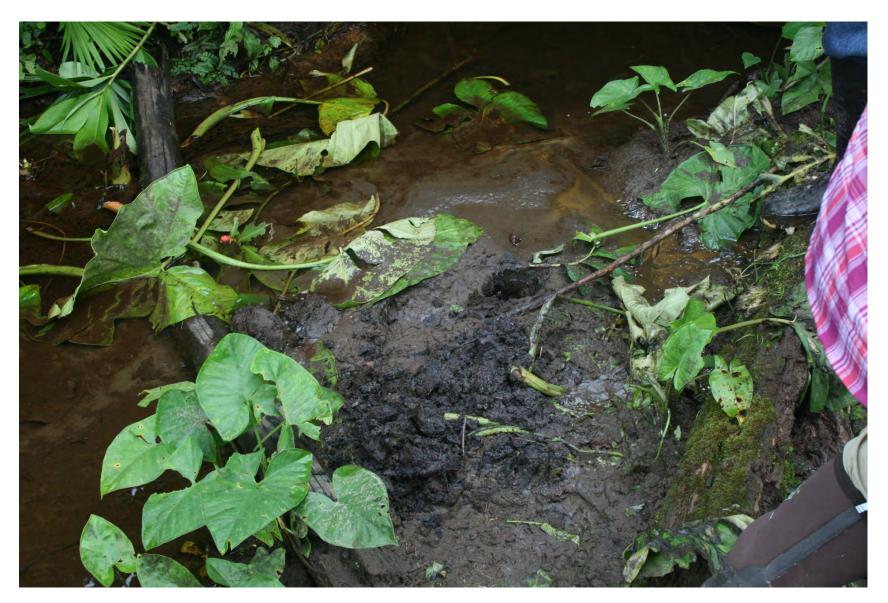
Photo 38 Contaminated sediment at LA-02

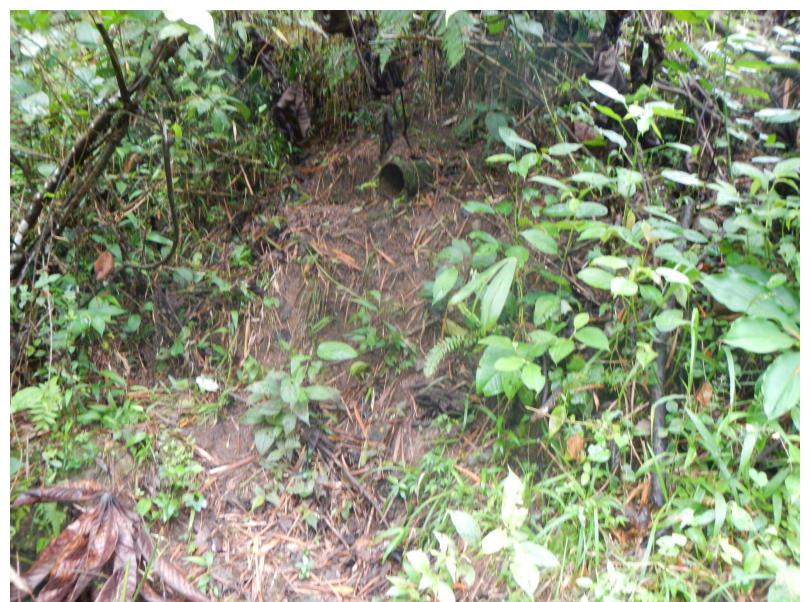
Photo 41 Siphon from Pit 3 at LA-02 (July, 2013)

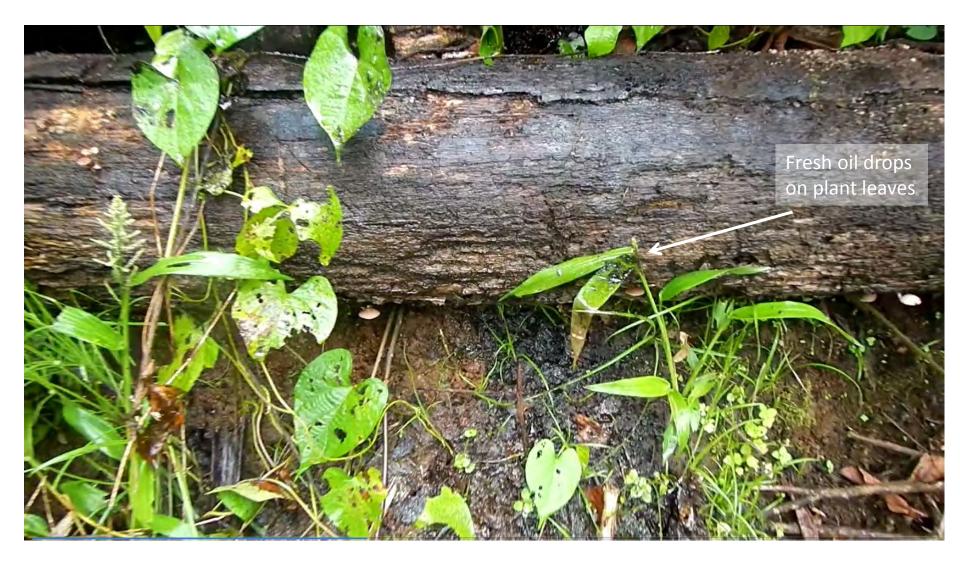
## Oil and water leaking from siphon (behind and above log) from buried, undisclosed Pit 3 at LA-02 (August 2014)

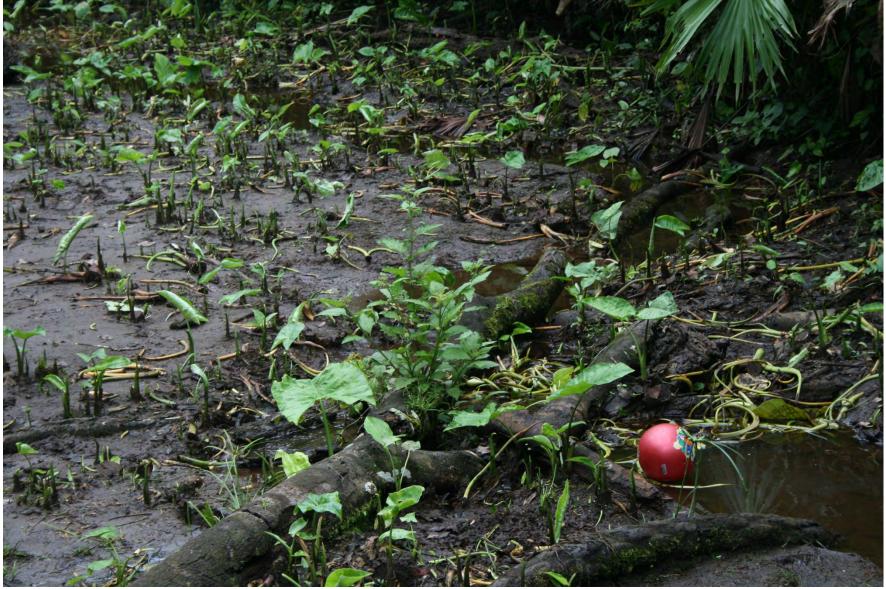
# Photo 43 Oil contaminated sediment and child's ball at LA-02

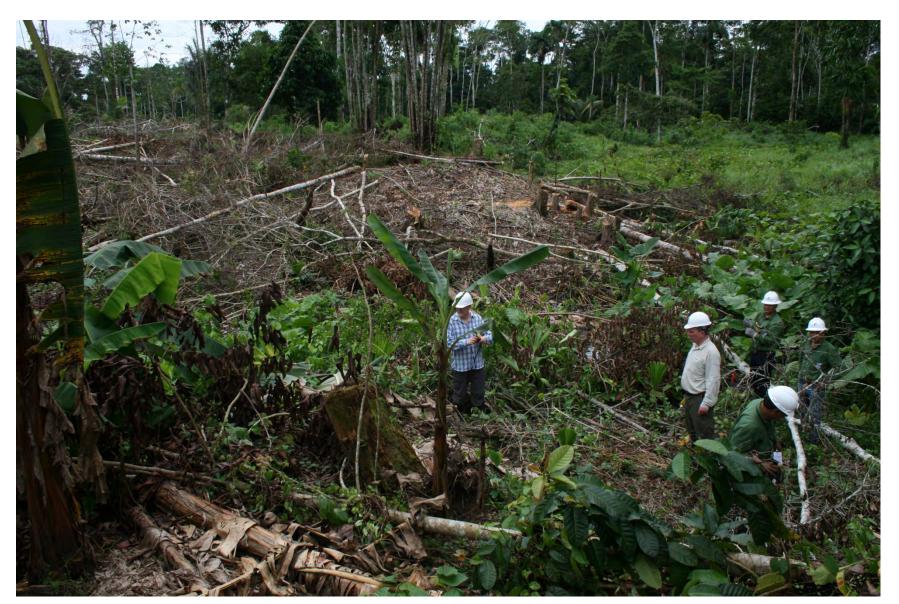
Area adjacent to stream impacted by Pit 3 at LA-02 – Area is being cleared for use.

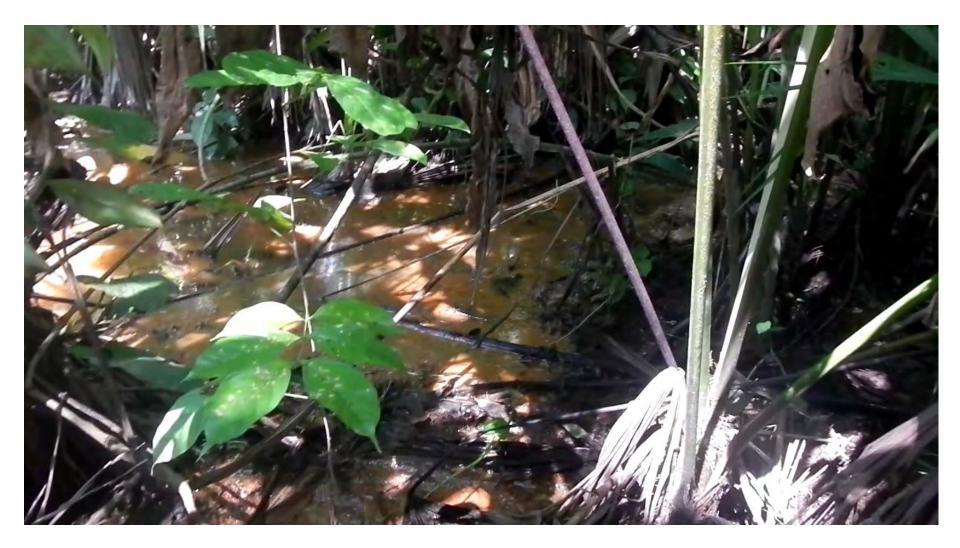
Photo 46 Oil-contaminated wetlands at SSF-55

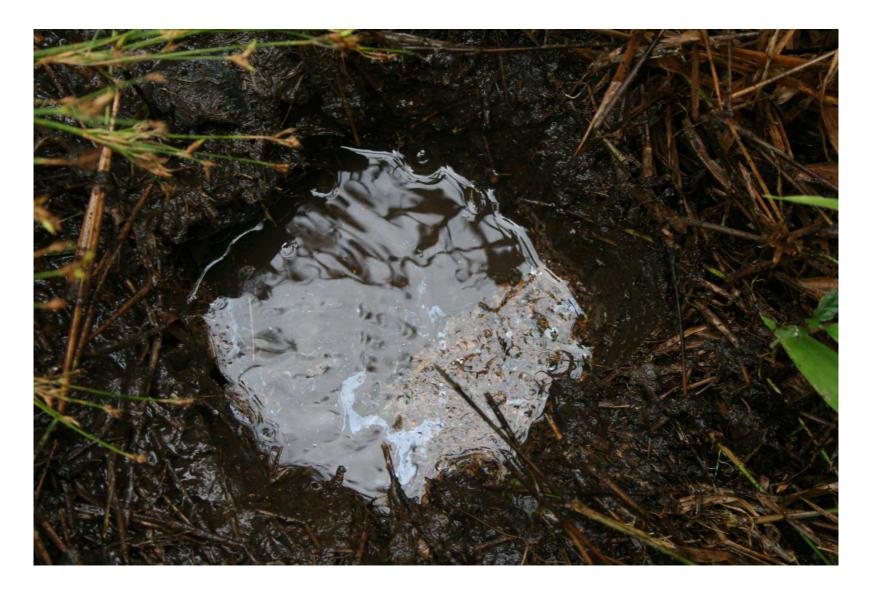
# Photo 49 Petroleum sheen on water in wetland at SSF-25

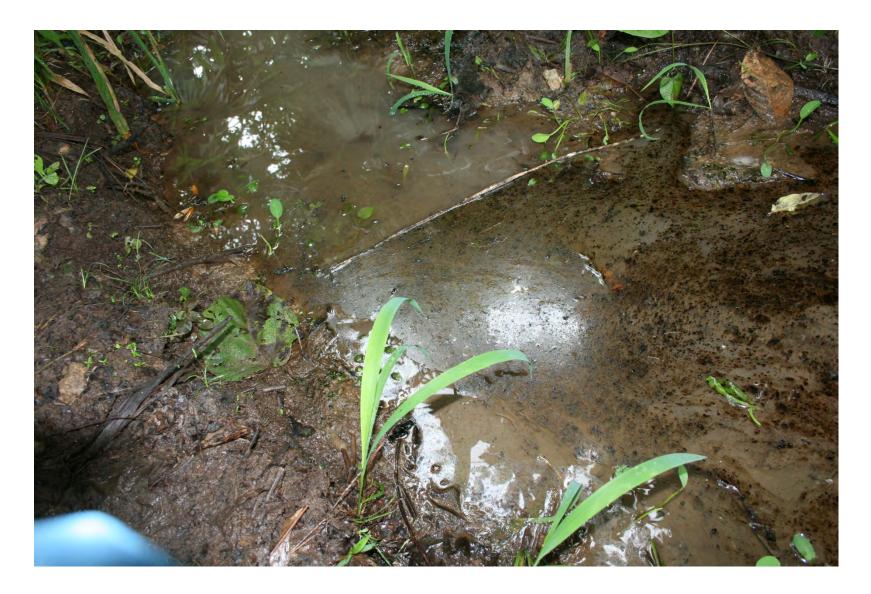
# Photo 53 Oil and petroleum sheen on a stream at YU-02

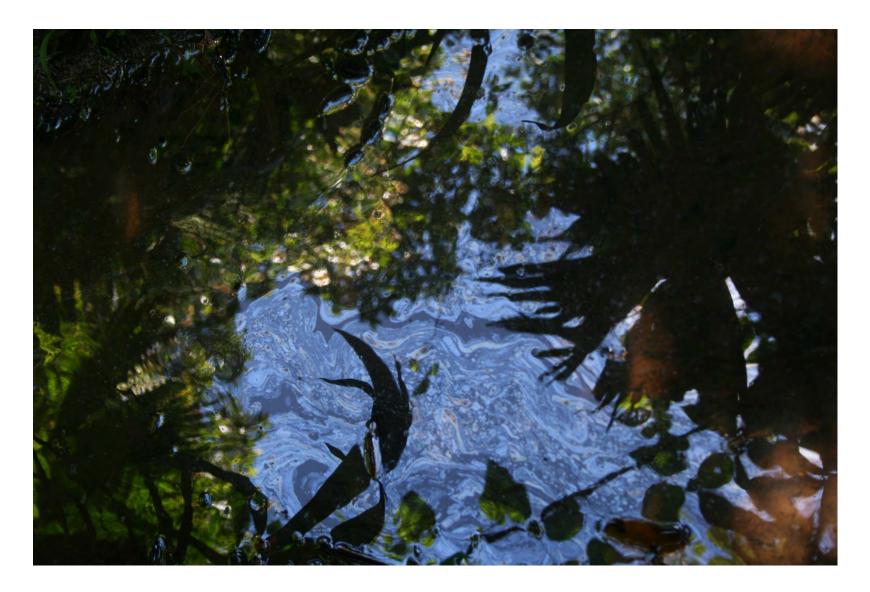
# Photo 55 Petroleum sheen in stream at YU-02

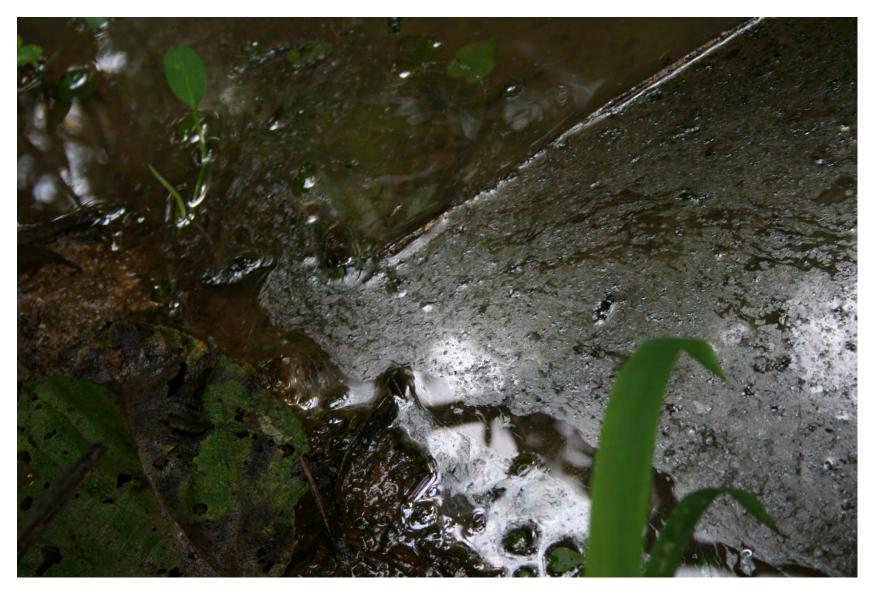
# Photo 57 Oil sheen and droplets on water at YU-02

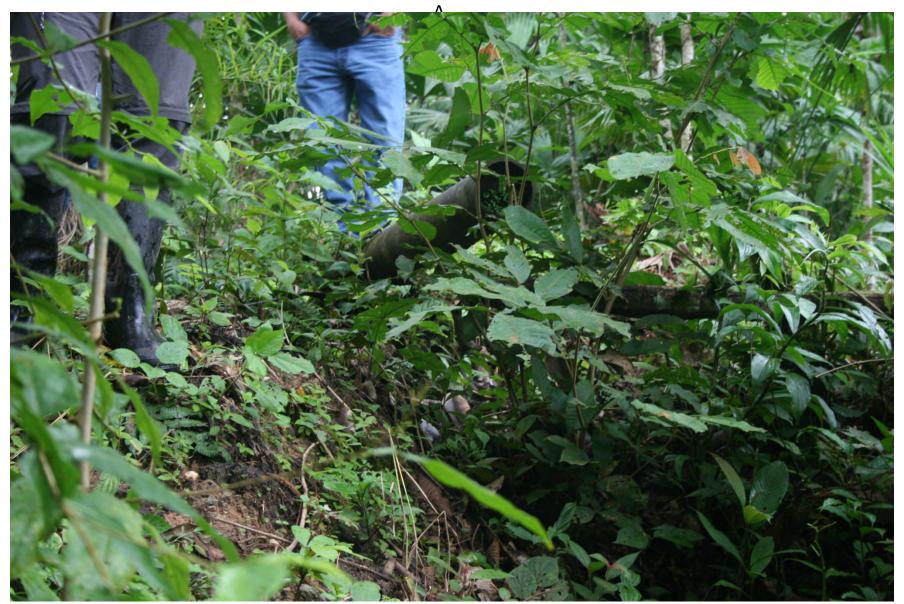
Siphon pipe protruding from Pit A berm at GU-06 indicating pit was designed to contain oil. Note the highest concentrations of barium detected by LBG in soil (5080 mg/kg) were from inside Pit A

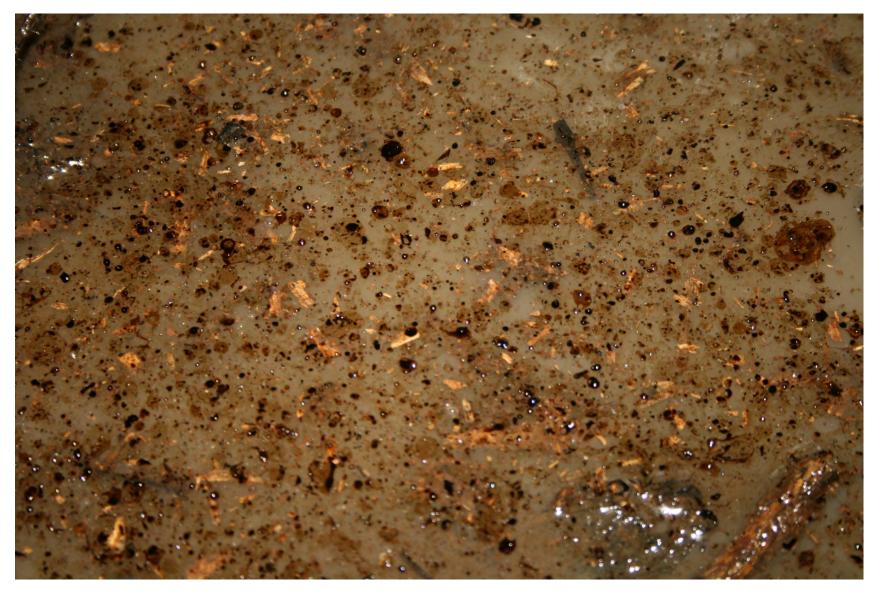
Photo 66 Oil droplets on water at GU-06

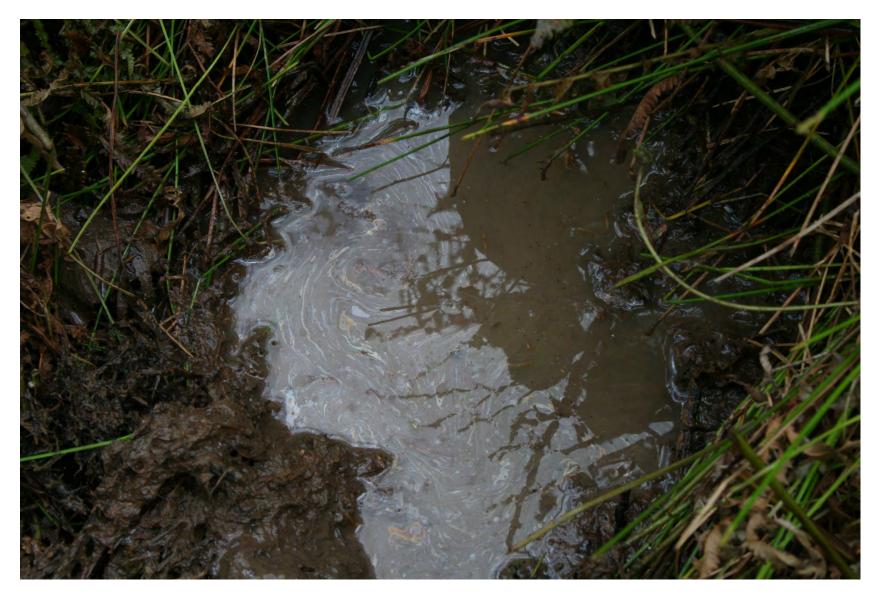
# Photo 70 Petroleum sheen on water at AG-09

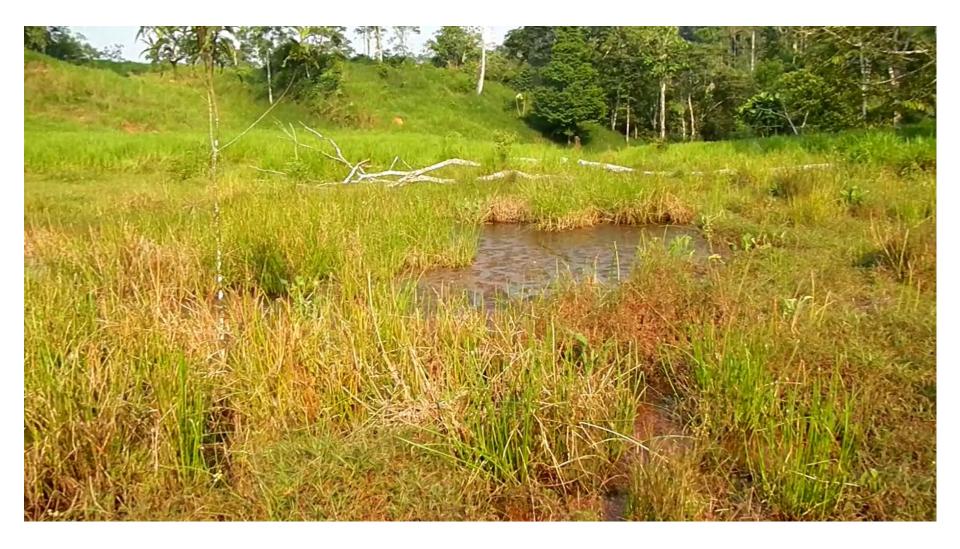
Photo 71 Degraded pond and wetland inside "RAP Remediate" Pit 1 at AU-19

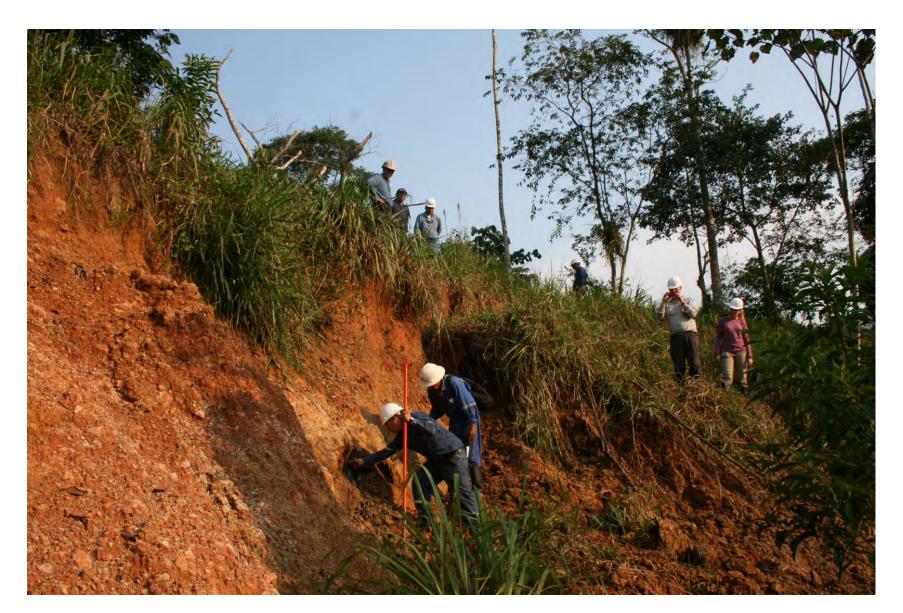
## Photo 72 Side of undisclosed Pit 3 exposed by slope failure at AU-19

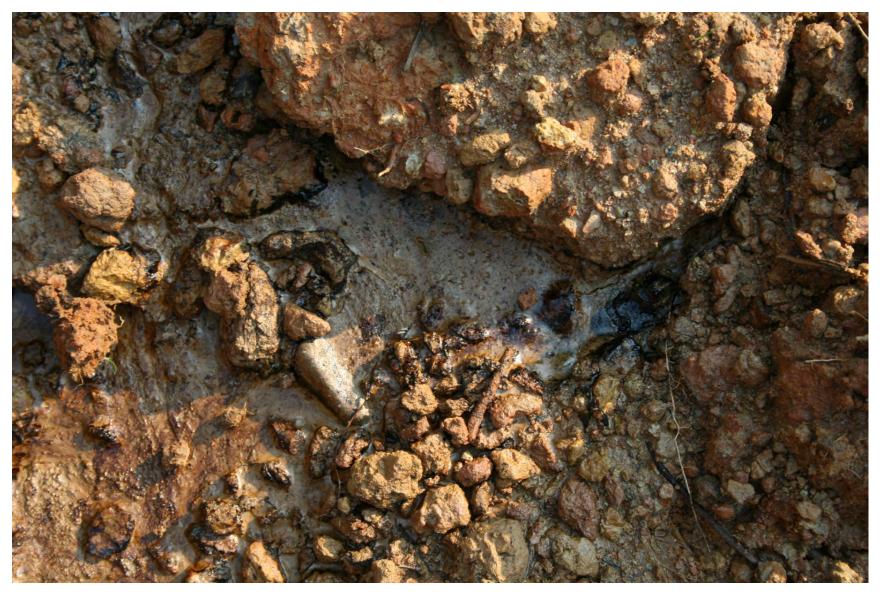
Oil seeping from side wall of slope failure at undisclosed Pit 3 in AU-19 (Photo 72)

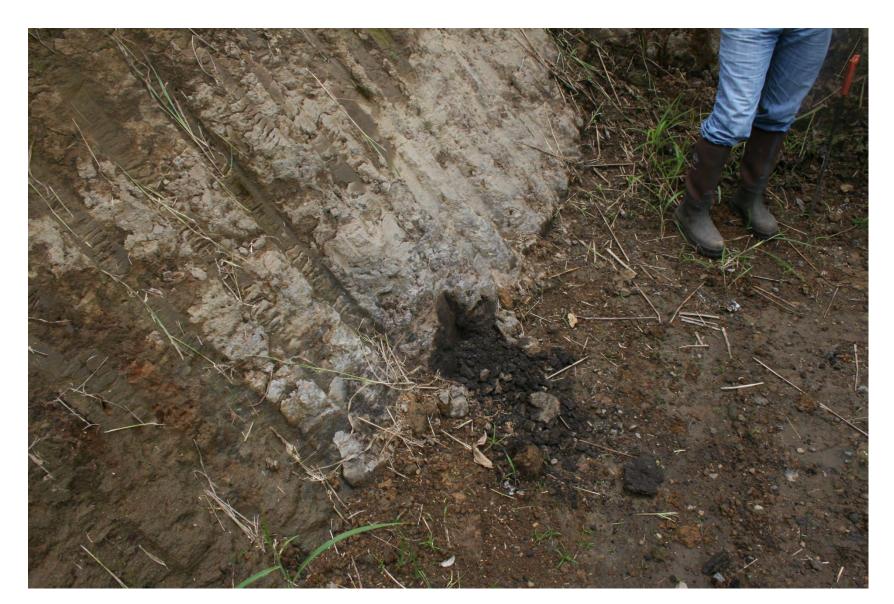
Land owner excavated into old pit without knowing former pit's location at SA-15

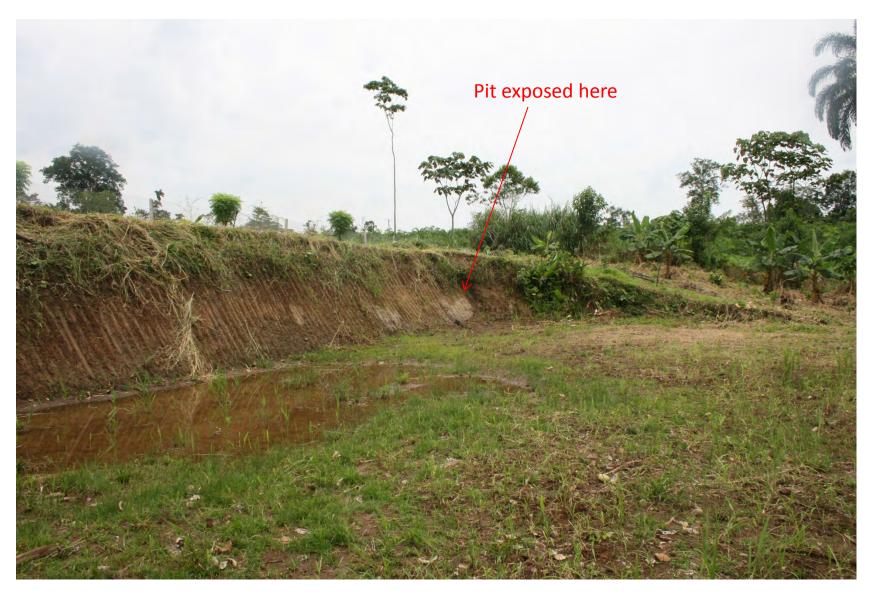
## Overview of farmer's excavation that exposed old pit at SA-15

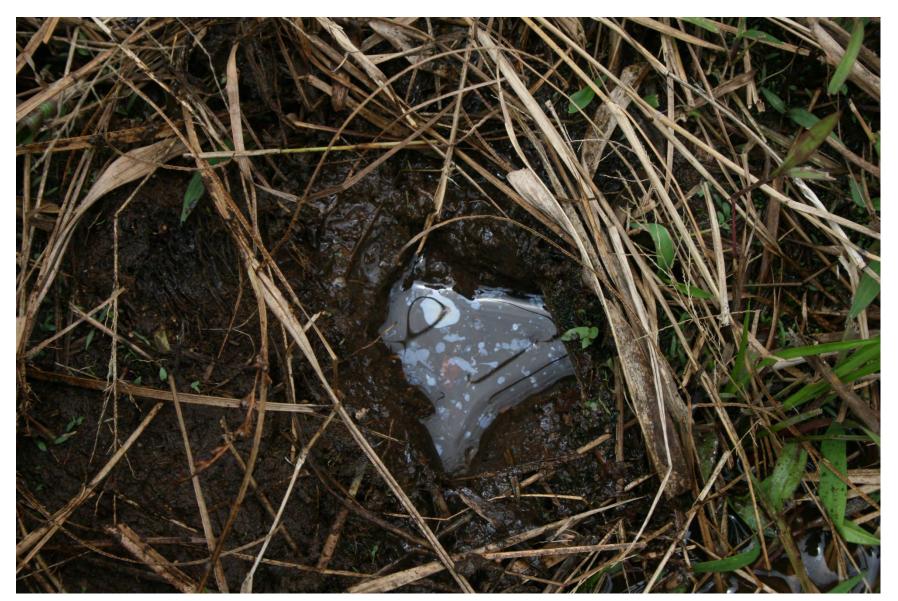
# Photo 76 Oil in sediment of marshy stream from spring at SA-15

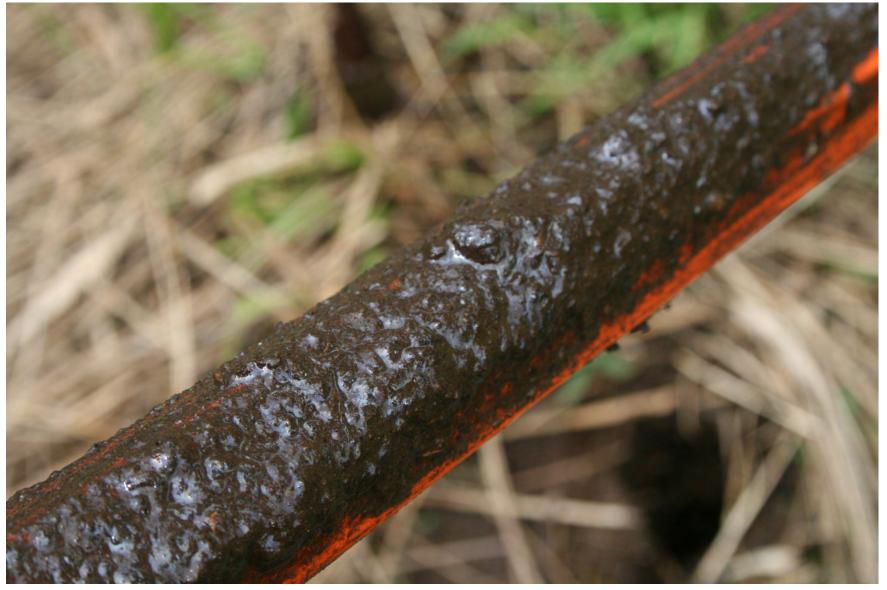
# Photo 77 Oil in sediment of marshy stream from spring at SA-15

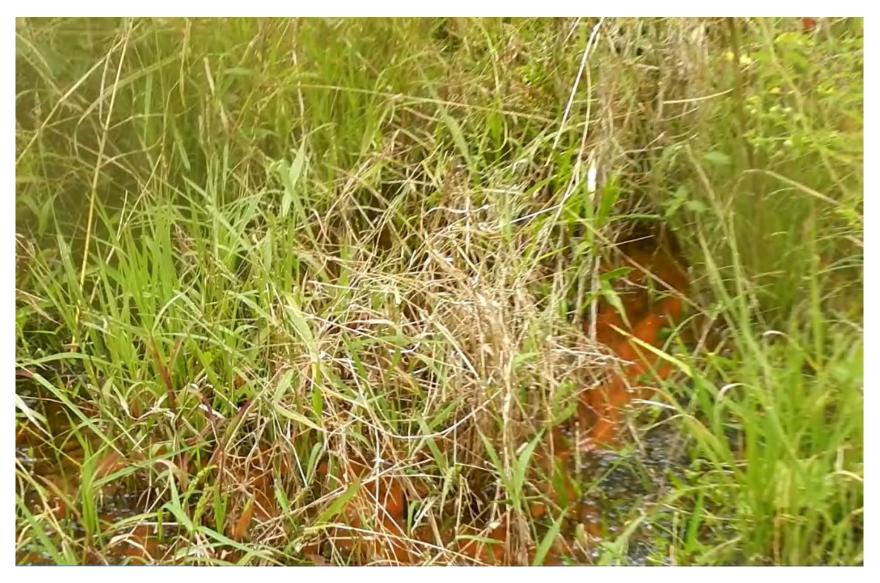
# Photo 78 Oil contaminated marshy stream from spring at SA-15

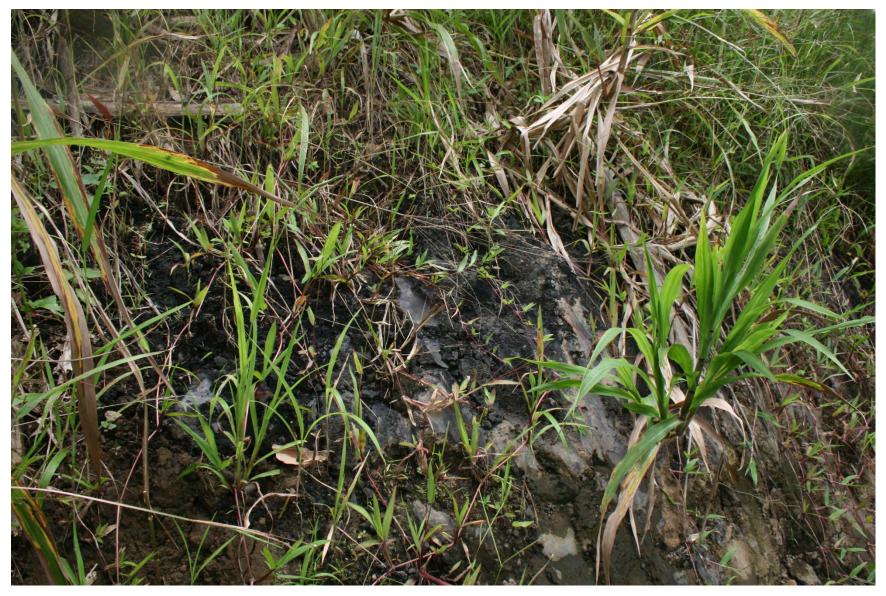
# Photo 79 Side of second excavation that hit another pit at SA-15

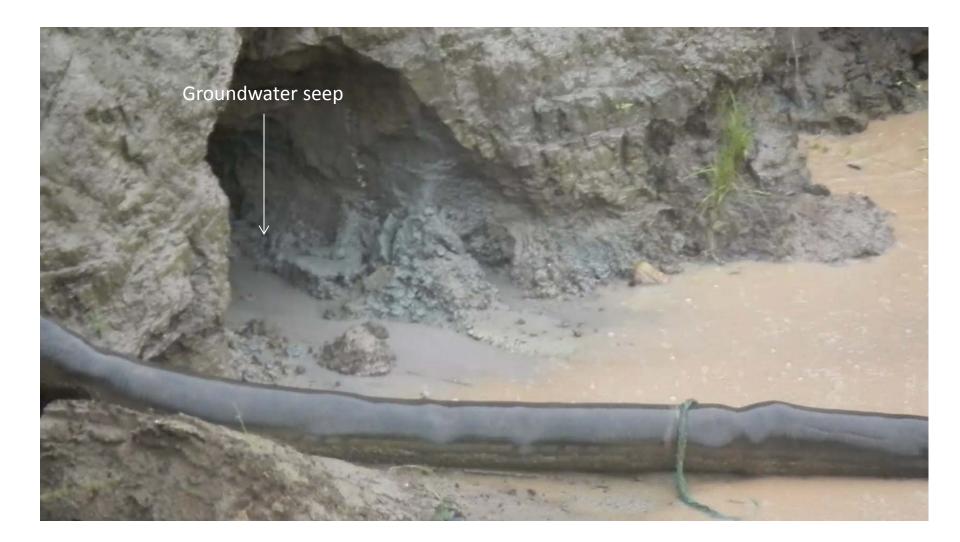
# Groundwater flowing into excavated pit with sheens on water at SA-54; hose connected to pump used to dewater the pit is in the foreground

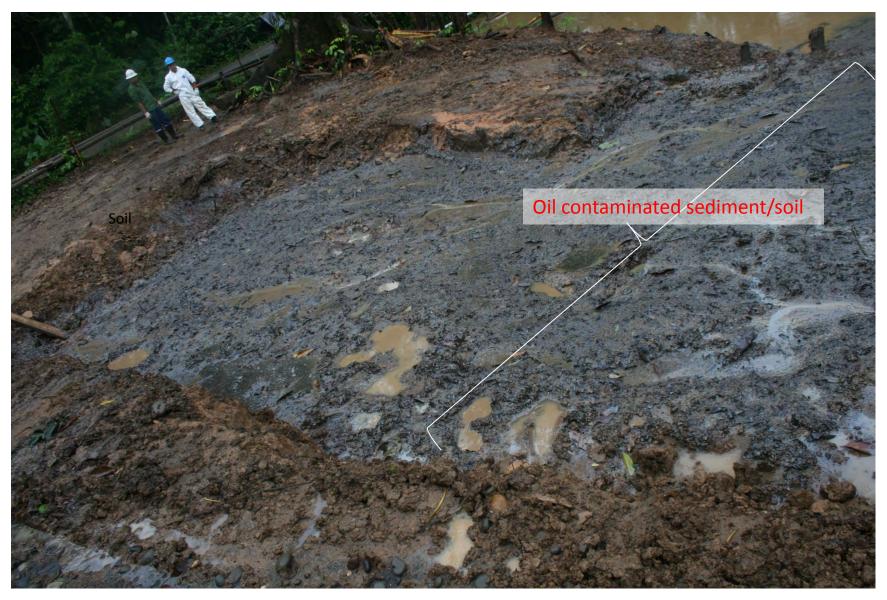
Exposed dark black sediment contains obvious petroleum impacts at SA-86

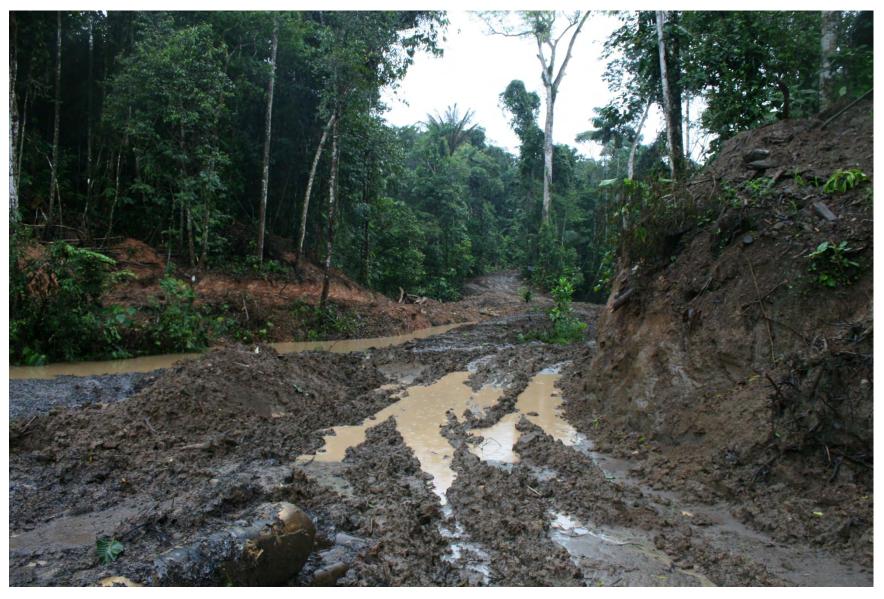
## Photo 92 Looking farther upstream from middle of remediation at SA-86

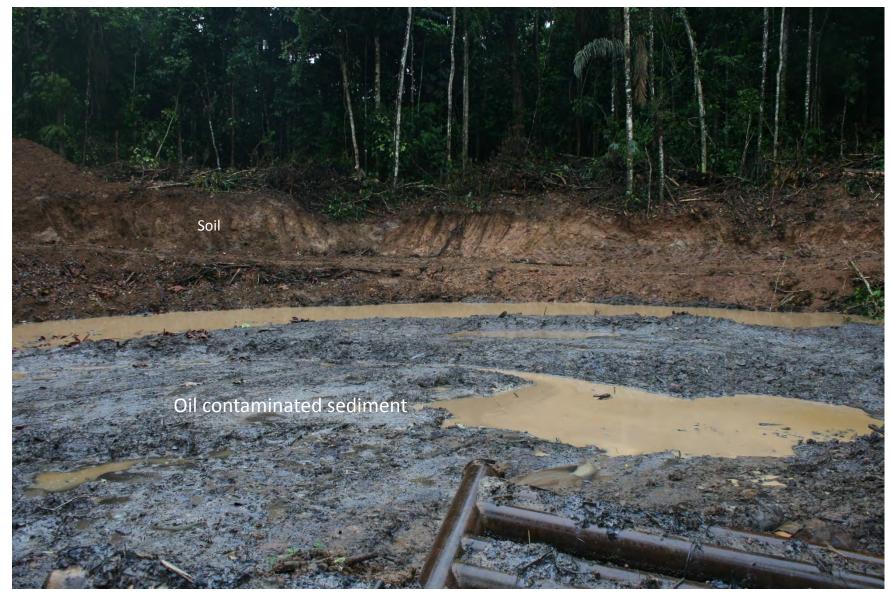
## Stream remediation showing exposed contaminated sediment at SA-86

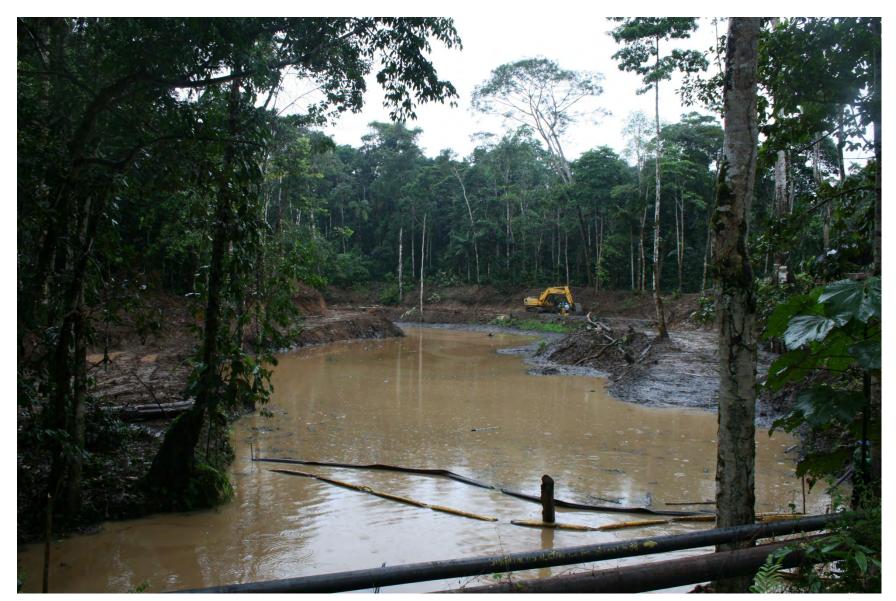
Photo 94 Looking upstream from bridge at SA-86
