# Appendix F

Photographic Collection from 2013 and 2014 Site Investigations

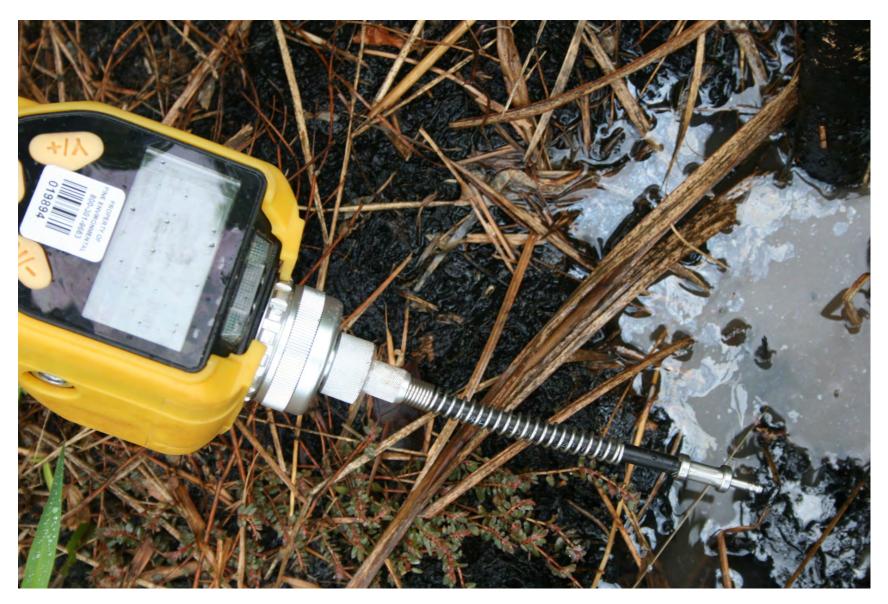
## Petroleum sheen in an undocumented pit with a PID reading of 97 ppm at SA-56

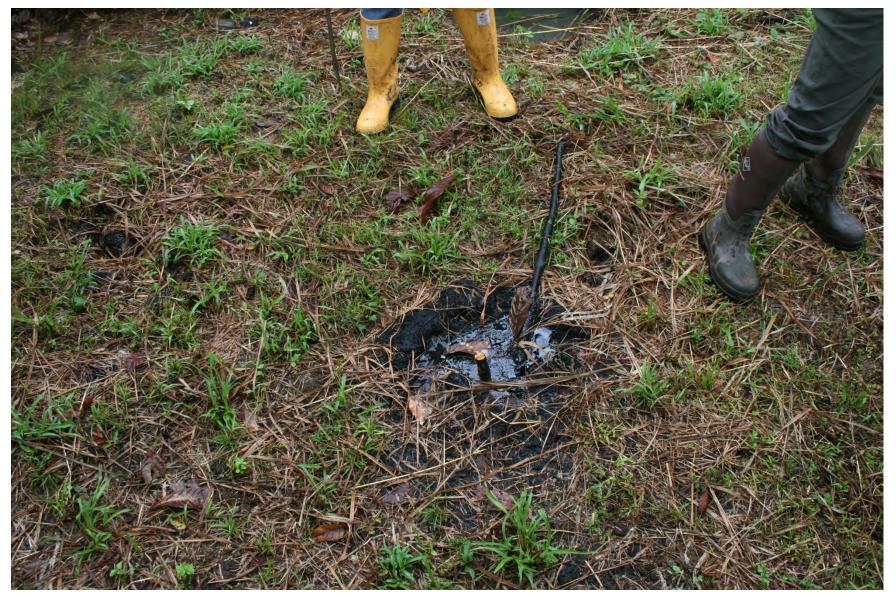
# Photo 96 Oil seep at undocumented pit at SA-56

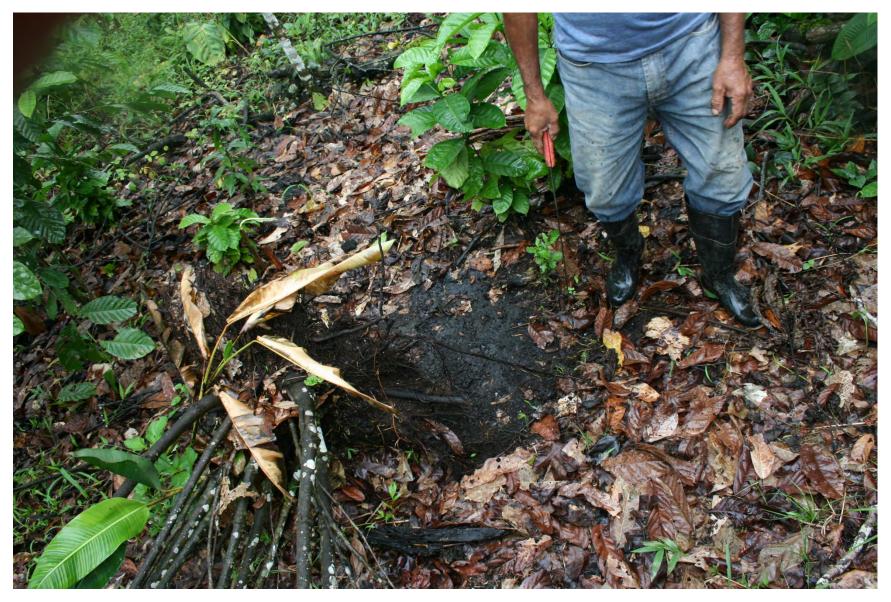
Photo 97 Hard asphalt under plants at SA-56

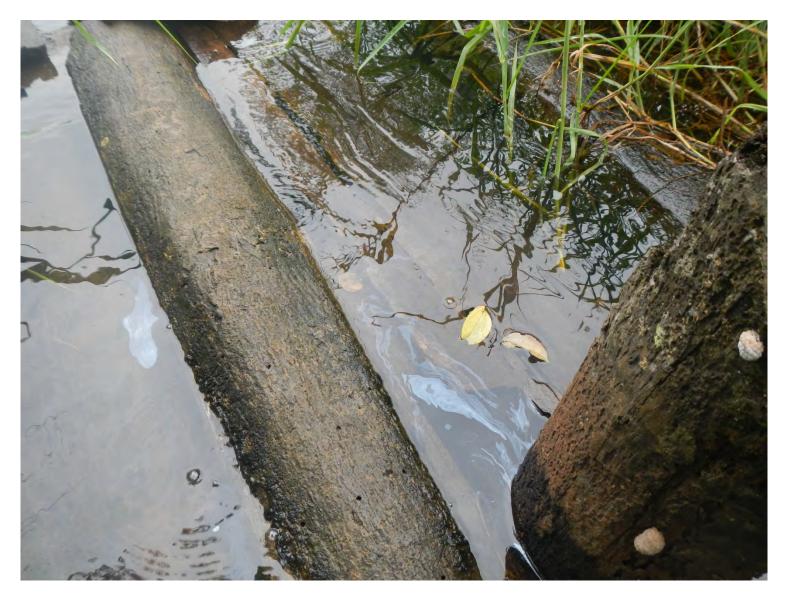
# Petroleum sheen in creek adjacent to piling foundations at SA-89

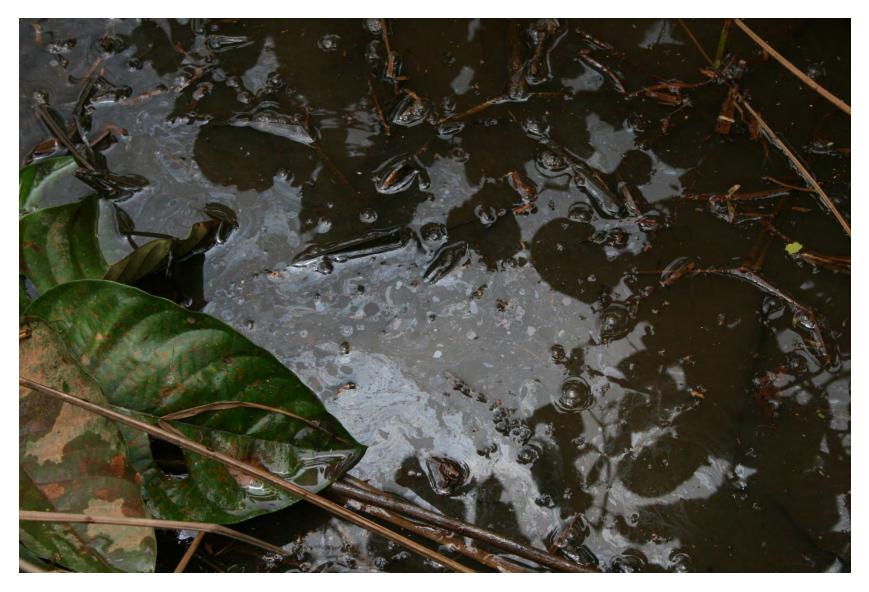
## Photo 99 Petroleum sheen on degraded stream at SSF-42A

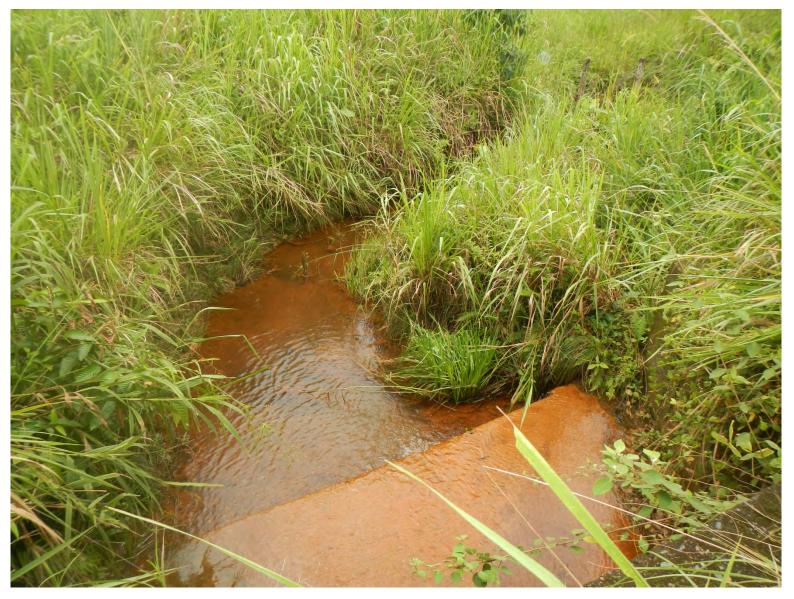
# Photo 100 Degraded stream adjacent to remediated pit at SSF-42A

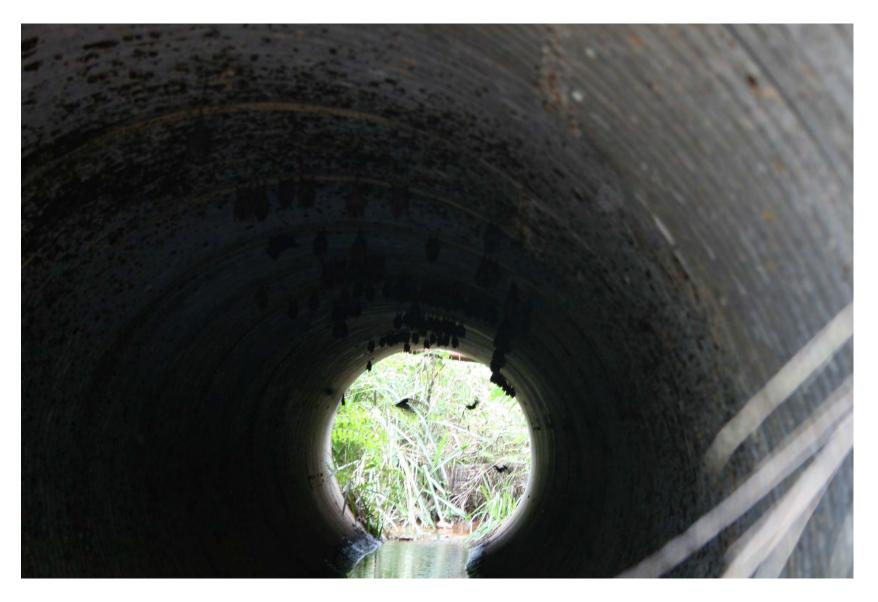
## Photo 101 Bats in a culvert for the degraded stream at SSF-42A

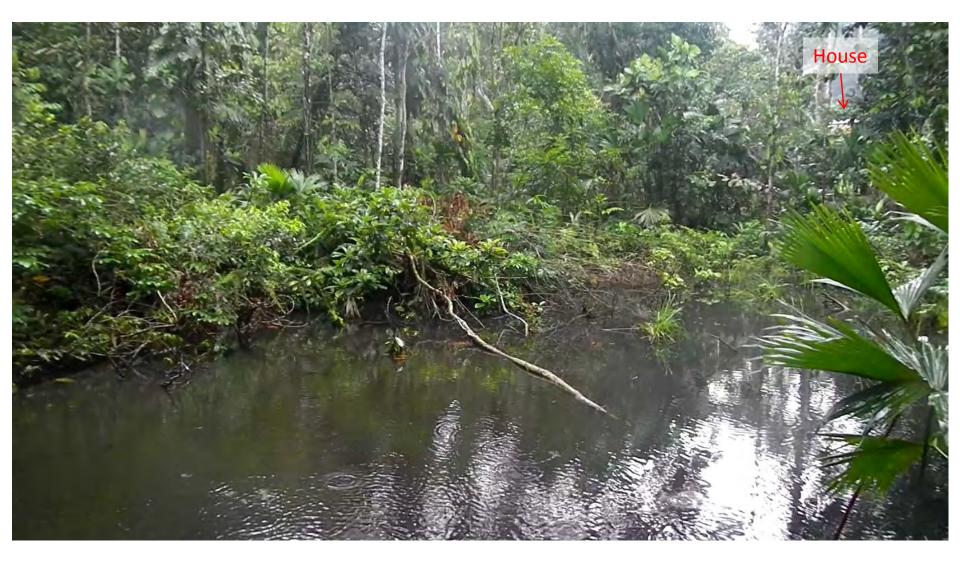
Un-remediated pit full of water used by local residents at YU-06, house in background Elevated PID readings were measured in the sediment from this pit

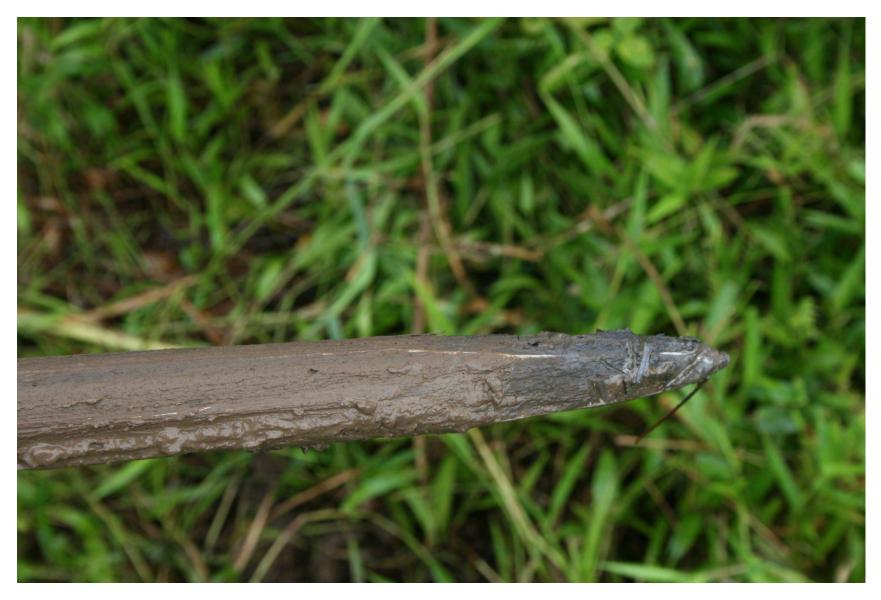
## Photo 106 Tip of digging bar was black from oil at SA-85

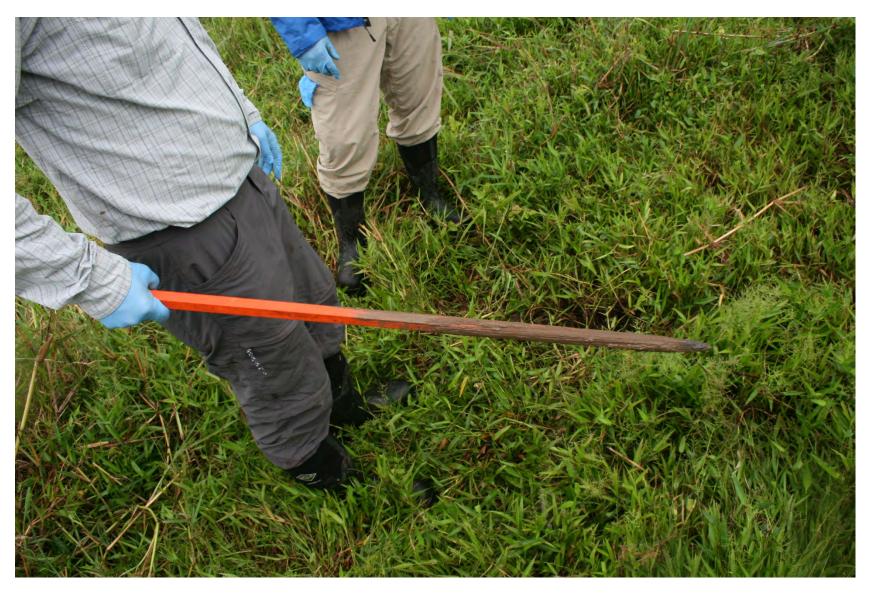
## Photo 107 Showing depth of cover (<0.5 m) and oil at SA-85

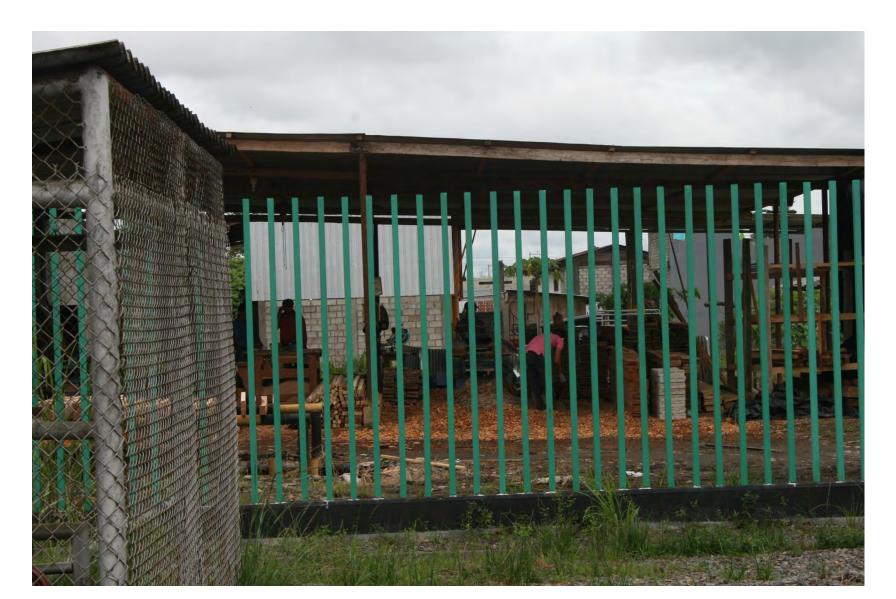
# Photo 108 New wood mill over pit at SA-6

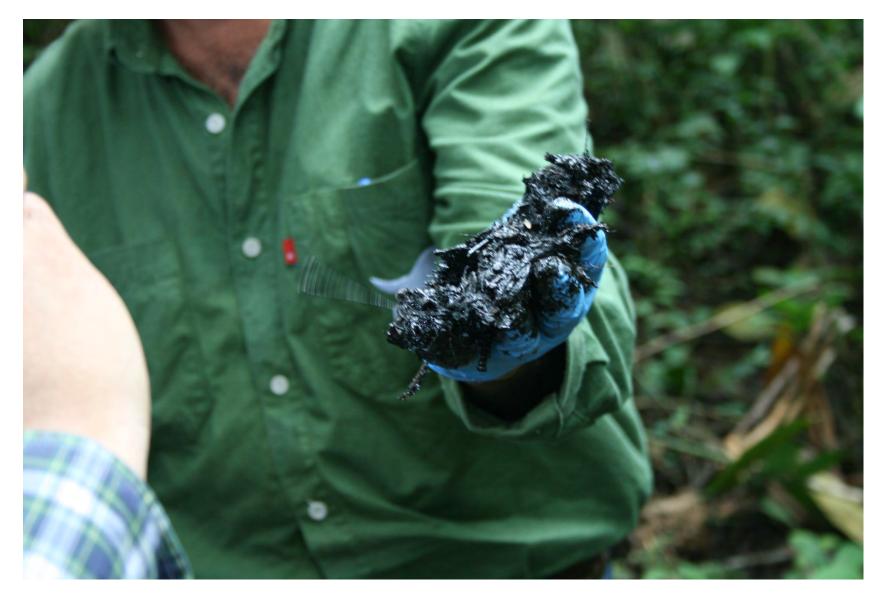
#### Photo 110 Pit 1 crude oil at CH-01

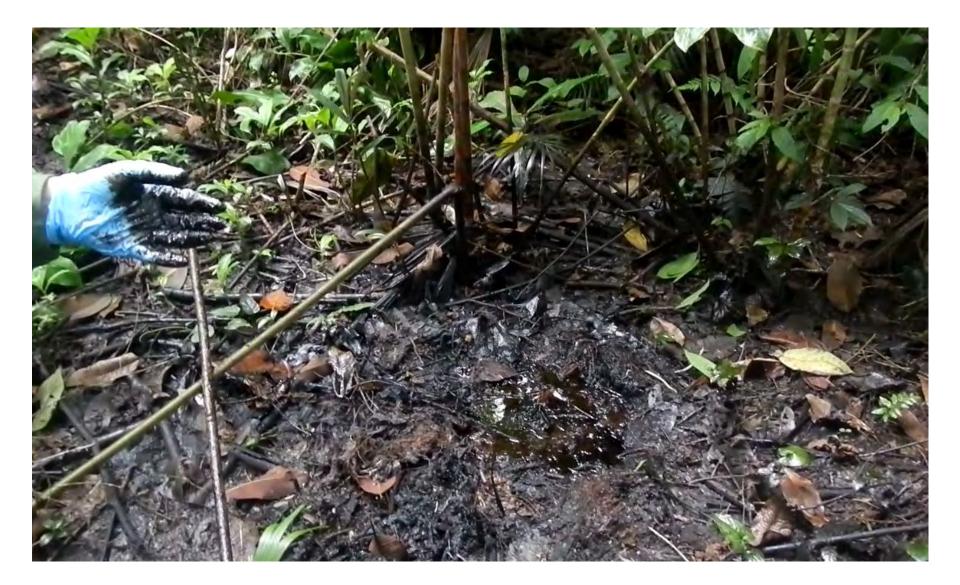
Pit 1 crude oil at CH-01; plants are growing on leaf litter covering 1 meter thick layer of oil

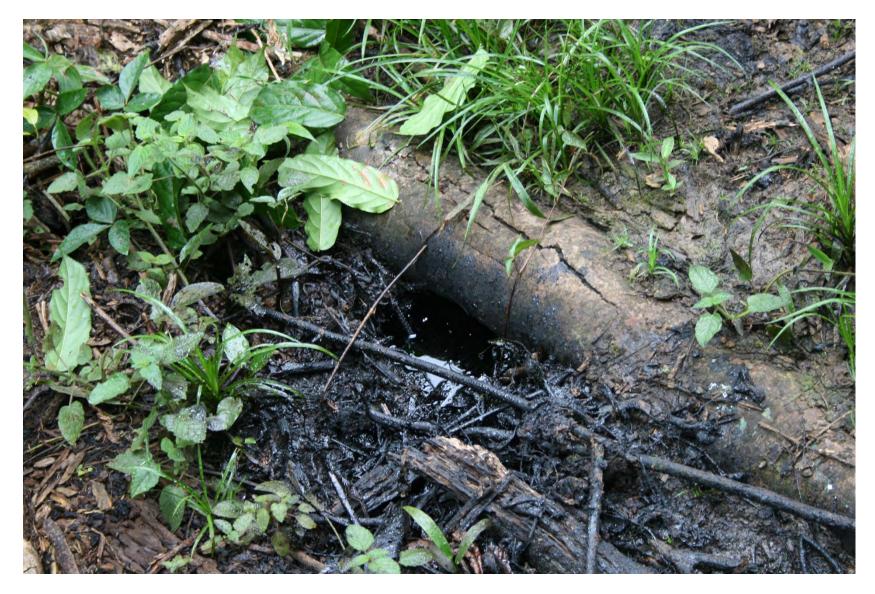
# Photo 112 Oil in pit 1 at AG-04

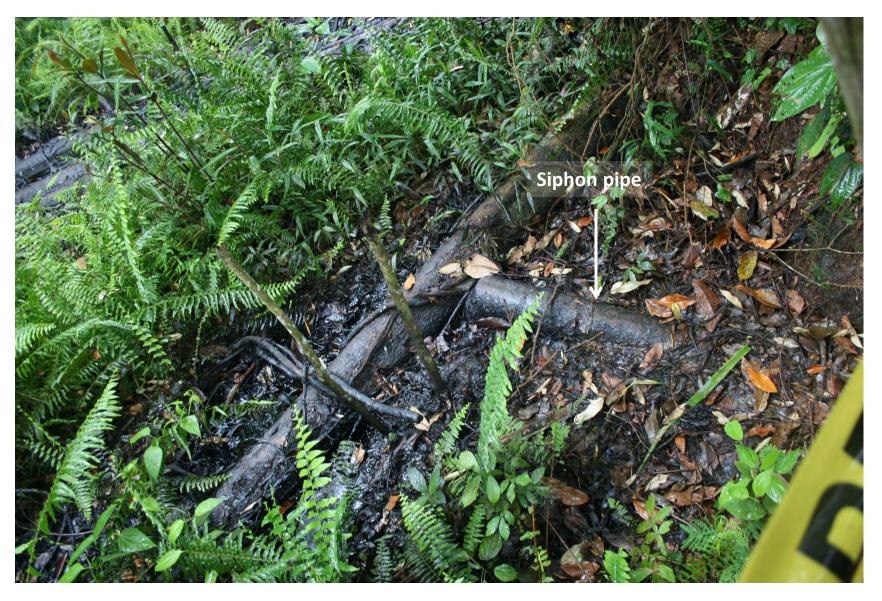
# Photo 113 Drainage pipe (siphon) on the pit side at AG-04

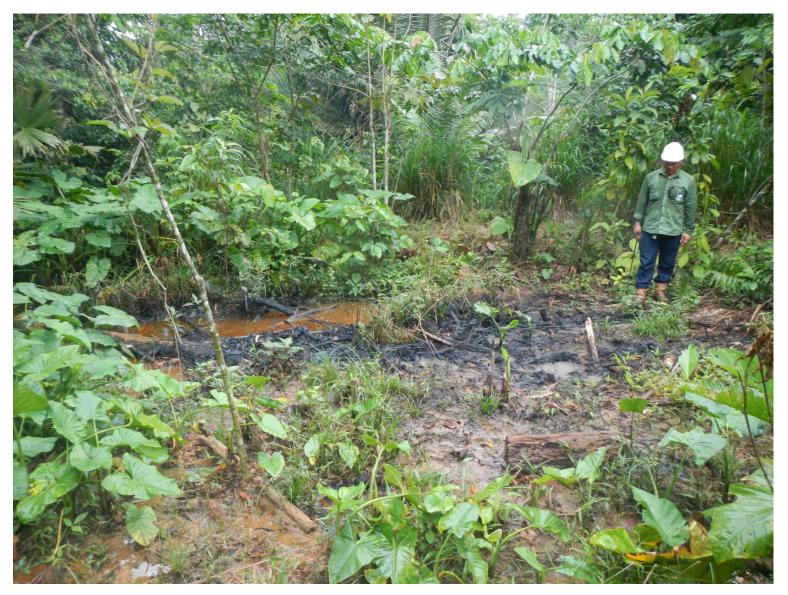
# Photo 114 Crude oil leaking from undocumented pit at AG-04

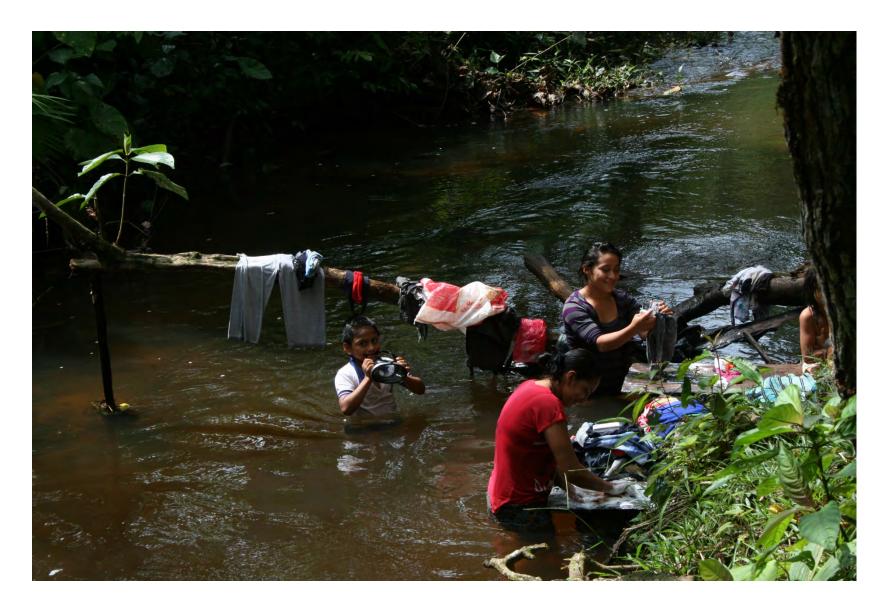
People washing clothes and playing in a stream where petroleum drains at AG-02

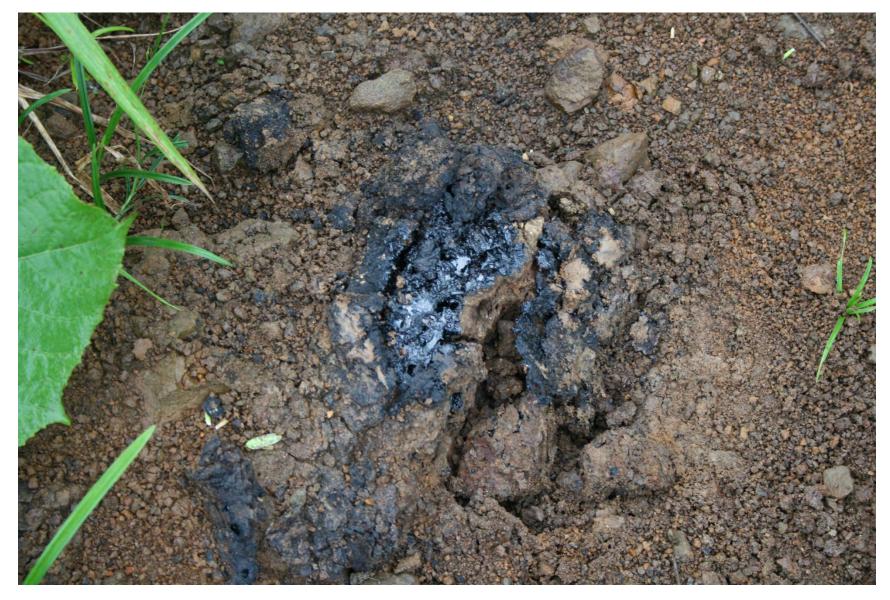
## Photo 119 Oil in soil

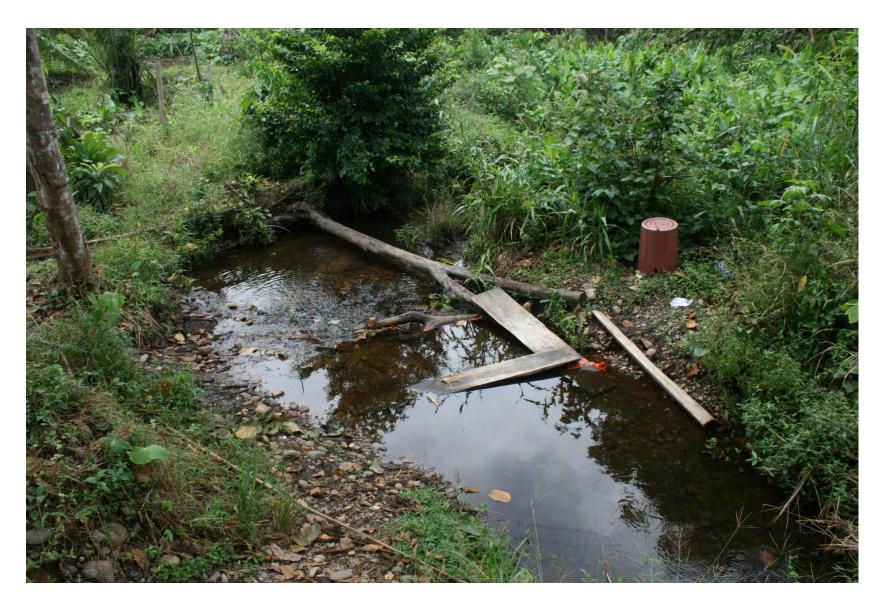
# Photo 121 Laundry area at SSF-37

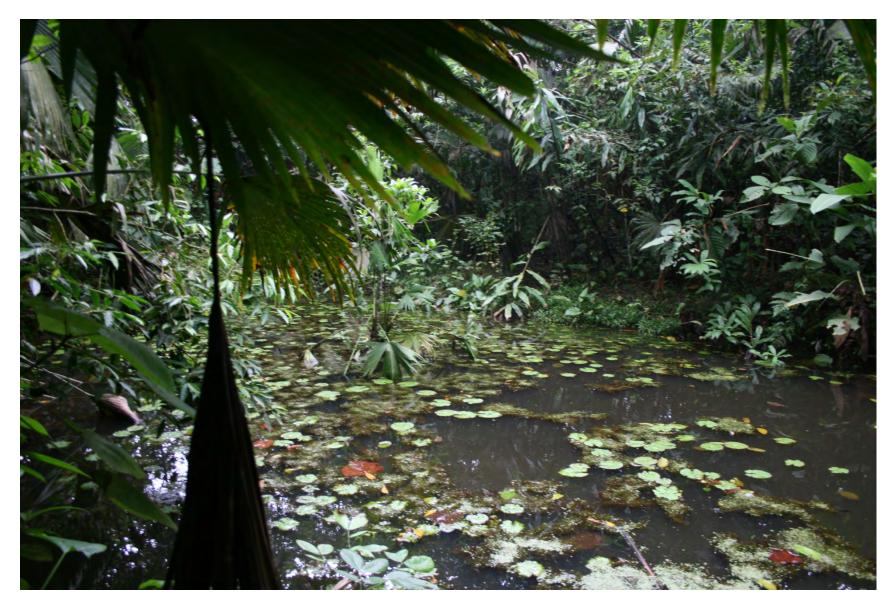
## Photo 123 Unremediated Pit 4 at YU-05

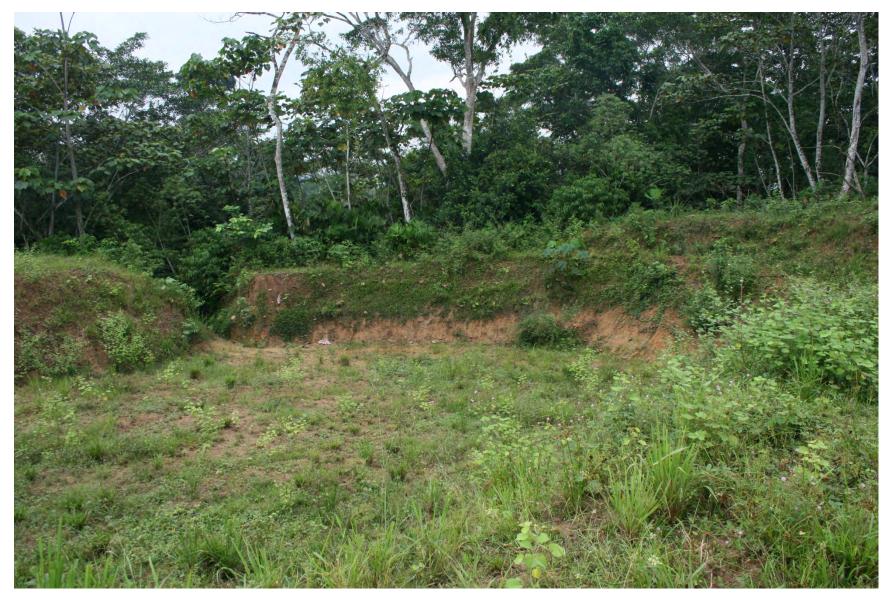
Photo 124 Remediated Pit 3 at YU-05

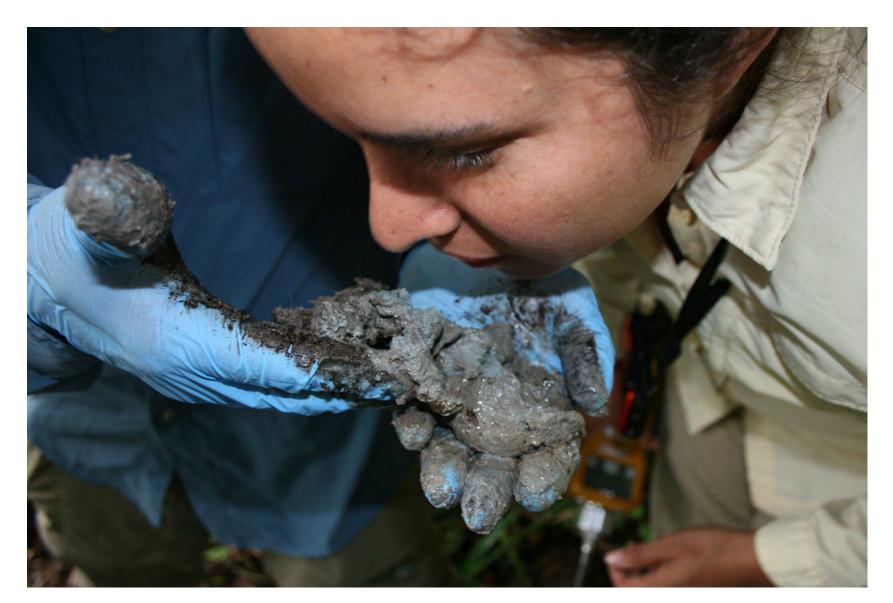
### Photo 125 Oil contaminated soil

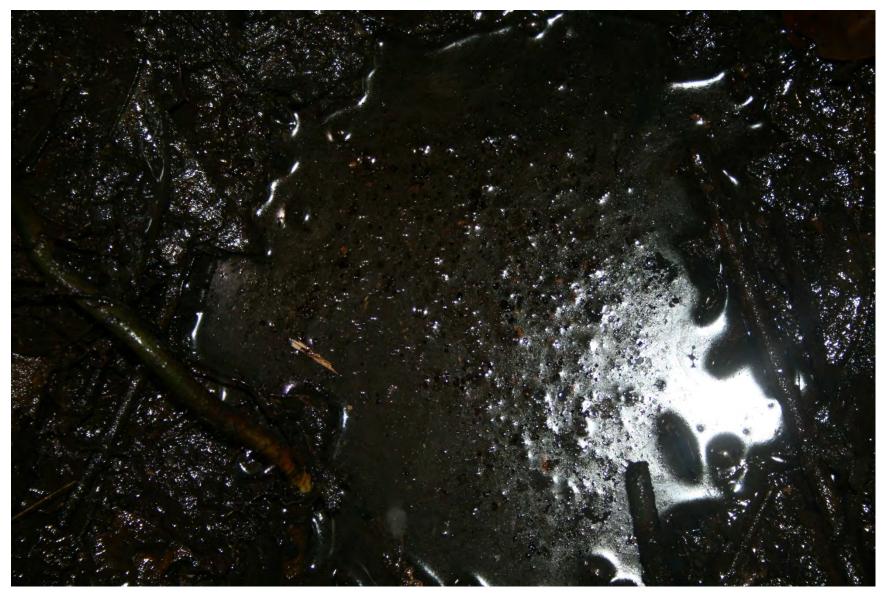
Photo 126 Oily sediment and water

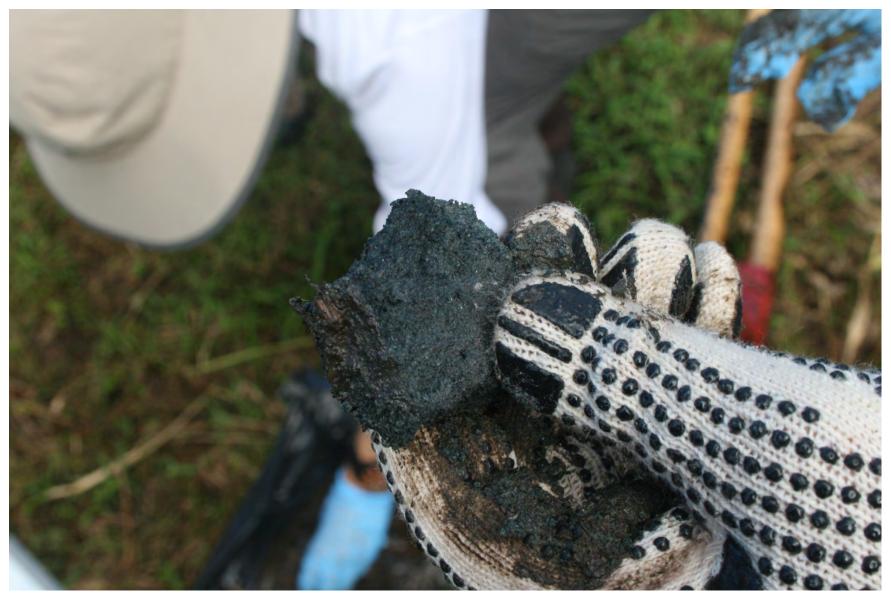
# Photo 127 Oily sand that smells strongly of oil from YU-02

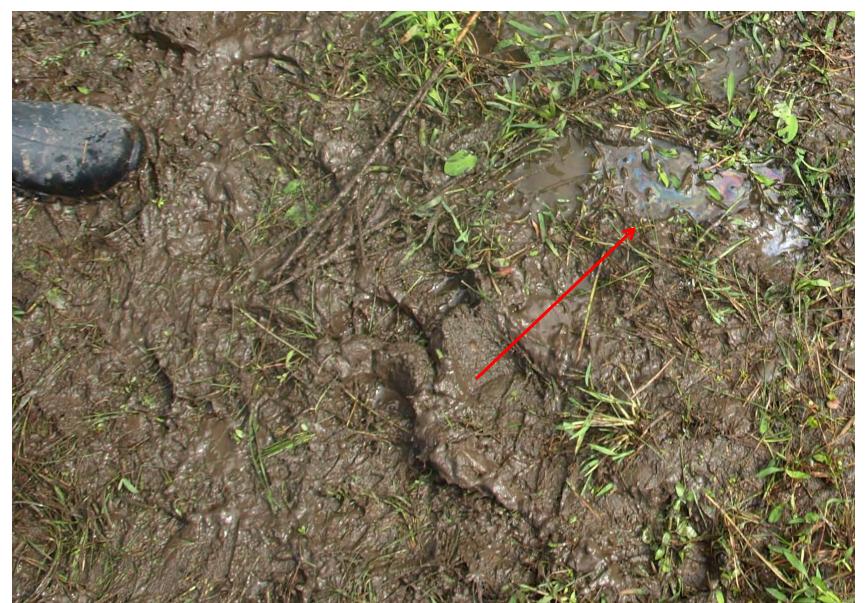
Photo 128 Sheen in footprint at YU-02

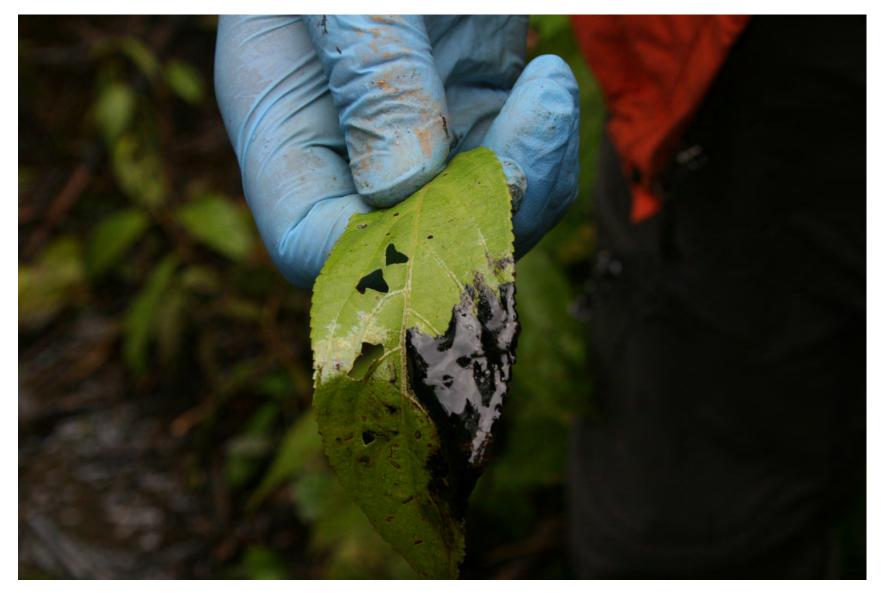
## Photo 129 Oil from stream on leaf

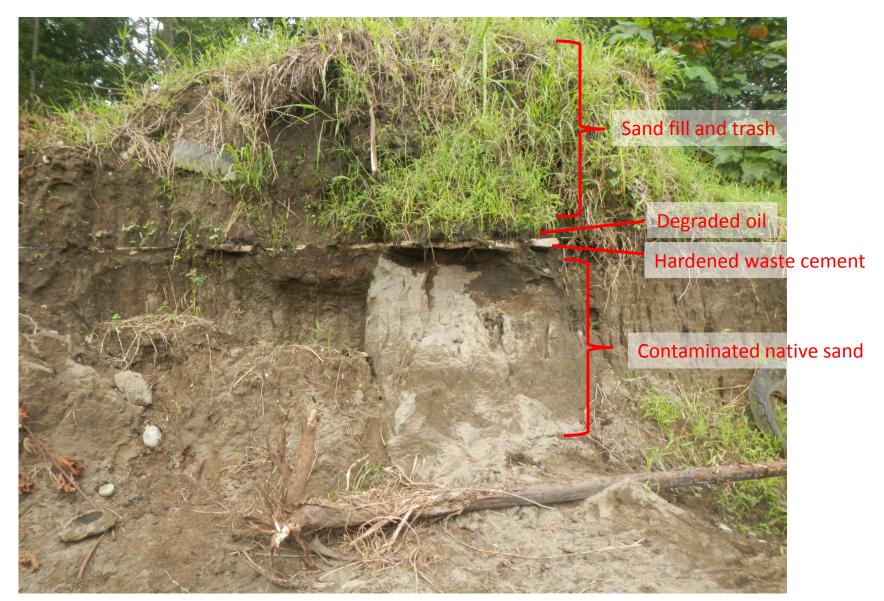
# Photo 133 Small un-remediated pit exposed in sand pit at SA-65
