# Appendix F

Photographic Collection from 2013 and 2014 Site Investigations

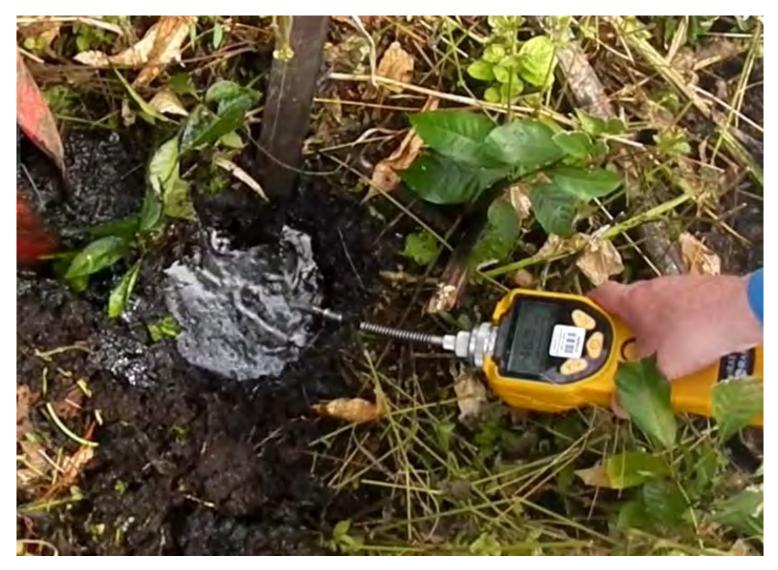
#### Photo 3 SSF-34

Liquid crude just beneath the surface at an undocumented TexPet pit that was discovered after a farmer expanded his fields. Petroleum contamination at this location exceeded all thresholds, including over **a thousand times** the Judgment cleanup standard.

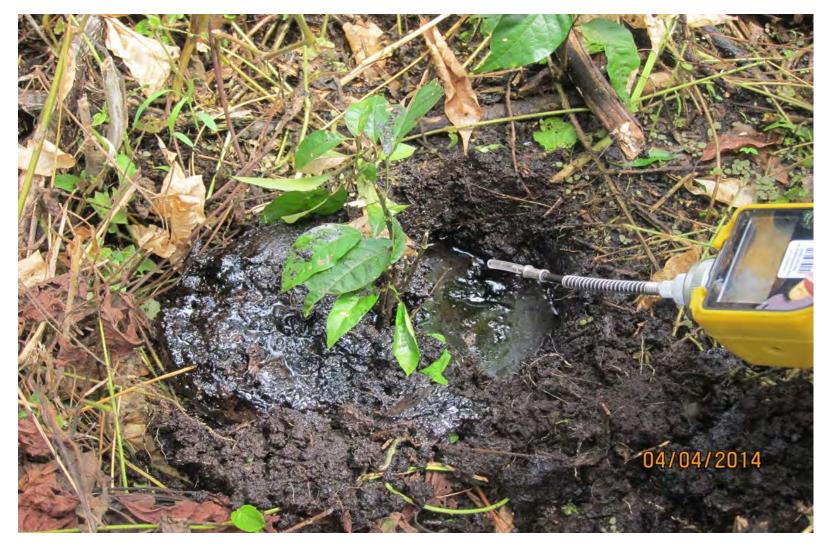
Crude at an undocumented pit at SSF-34 from different location than Photo 2.

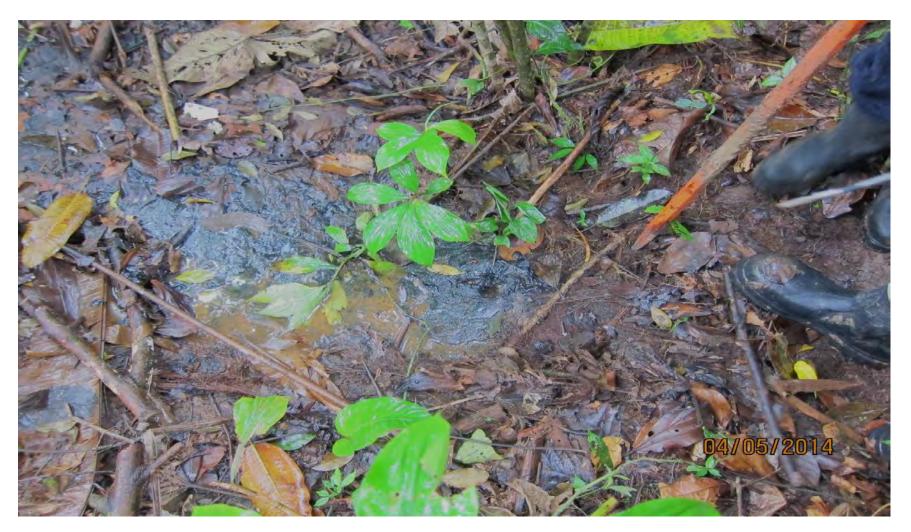
#### AG-06

Dr. Garvey using a PID to test the oil seep in the wetland. The PID reading of 164.6 ppm indicates that there is unweathered, liquid crude oil beneath the tar cover. This crude oil has migrated down from the TexPet pits uphill to the wetland area.

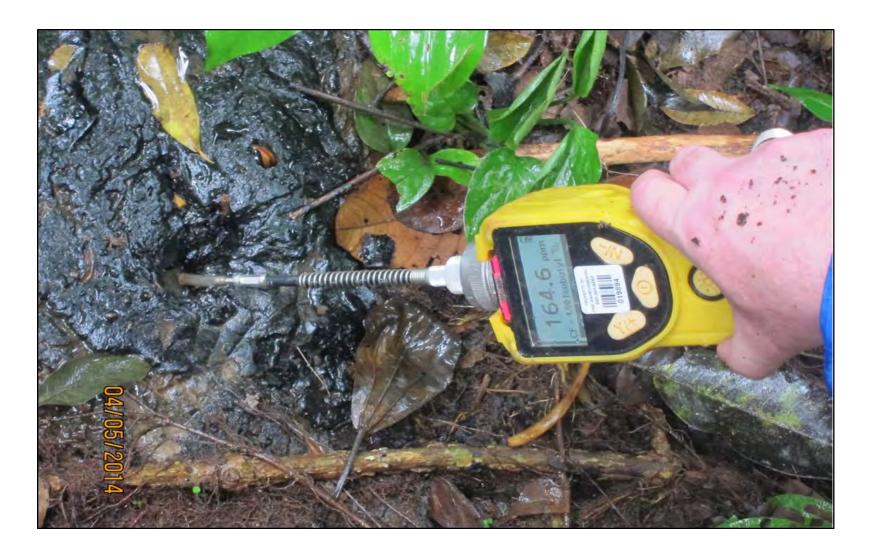
Oil contaminated soil and PID measurement of volatile organic vapors (21.6 ppm) indicative of oil contamination emanating from soil in the seep area at AG-06

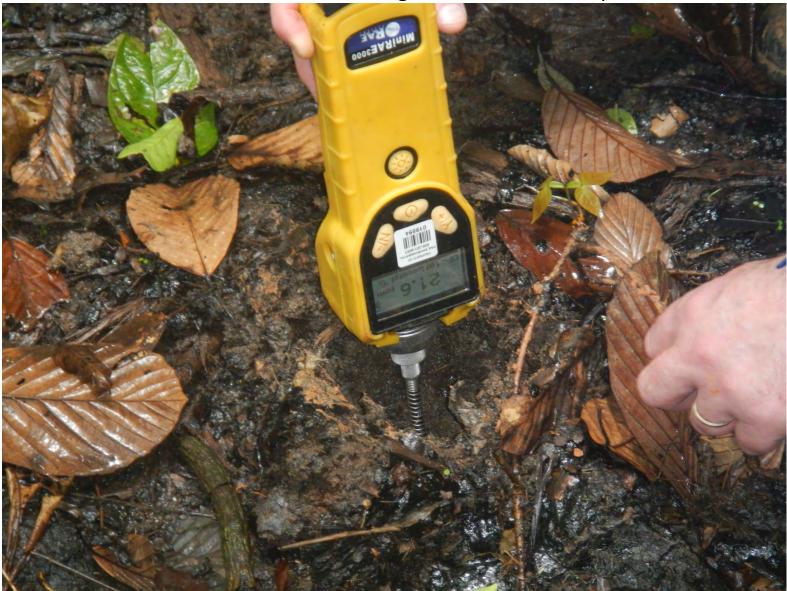
# Photo 15 Crude oil and tar beneath leaf litter in the seep area at AG-06

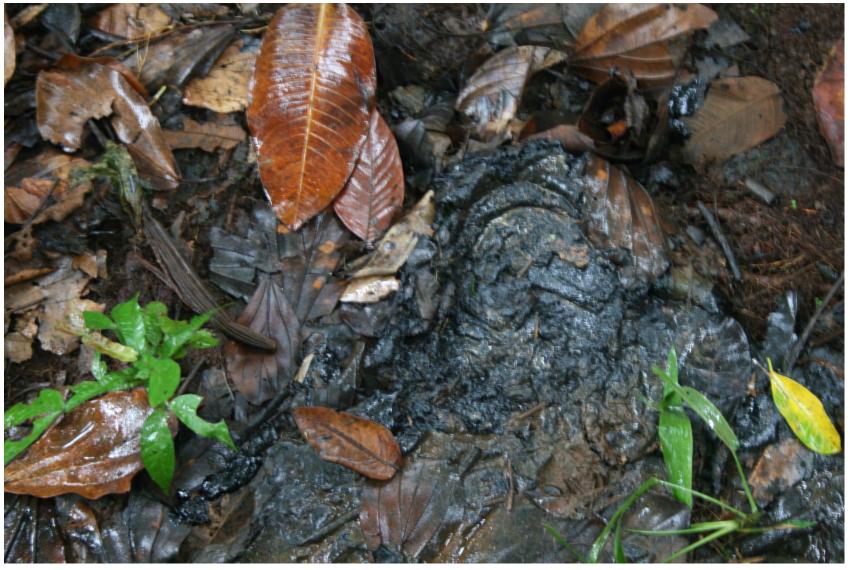
# Photo 16 Oil contaminated sediment beneath leaf litter at AG-06

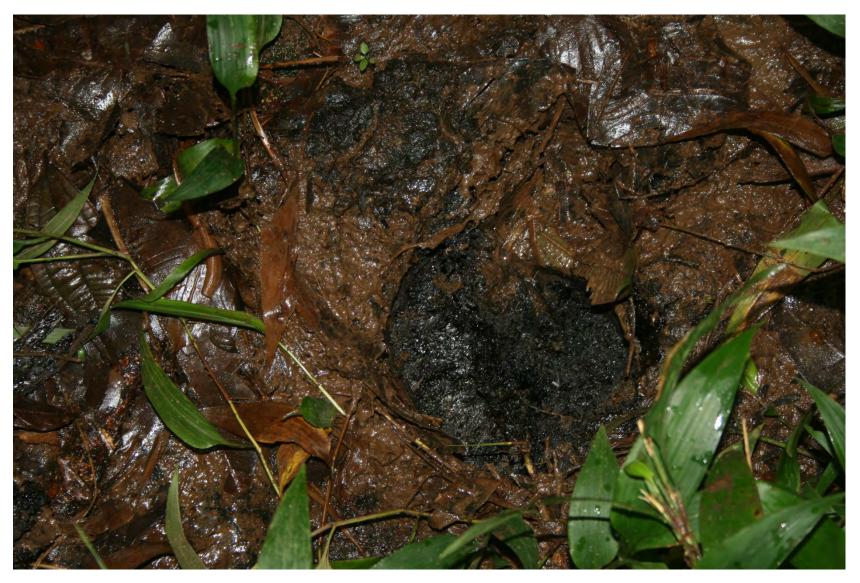
# Photo 17 Oil contaminated soil beneath leaf litter at AG-06

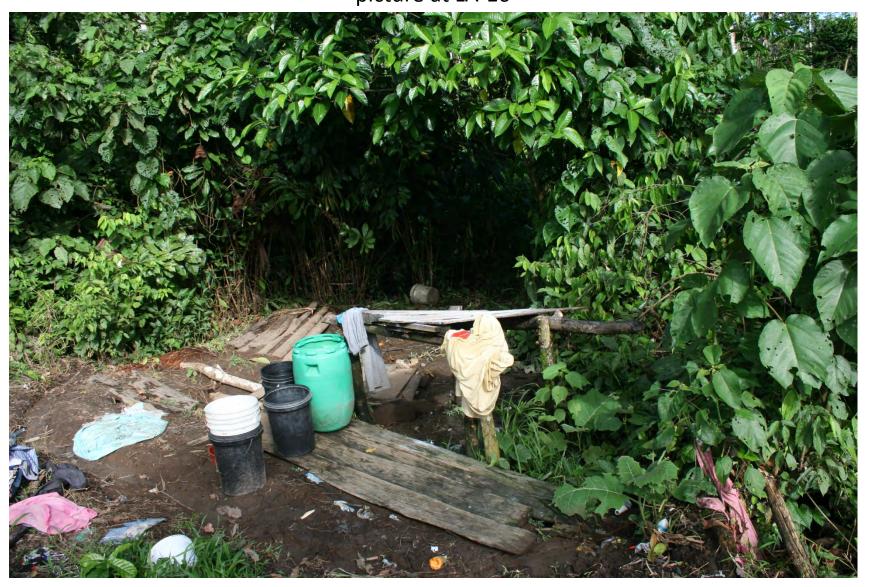
Location where petroleum evident in soil and water next to hand dug well at LA-16

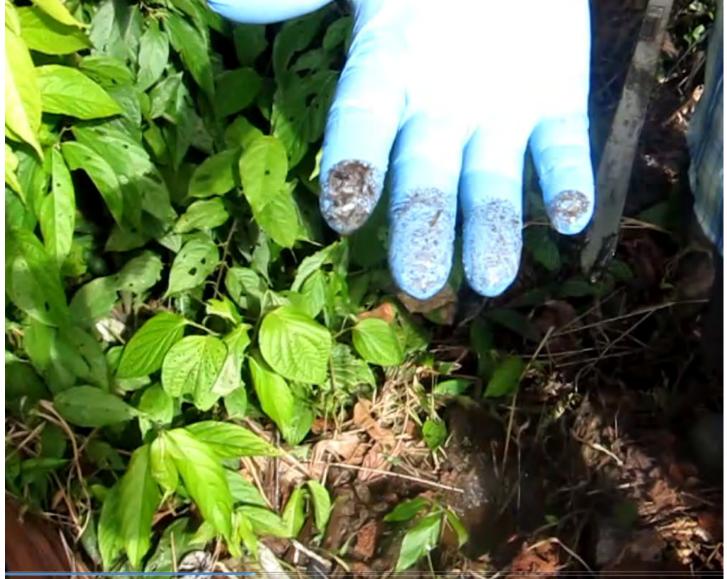
#### LA-16

Cleared cornfield that is east of two TexPet pits. PetroEcuador employee is using a digging bar to visually examine the soil as local residents look on. Samples collected in this area were **twenty-five times** the Judgment clean-up standard.

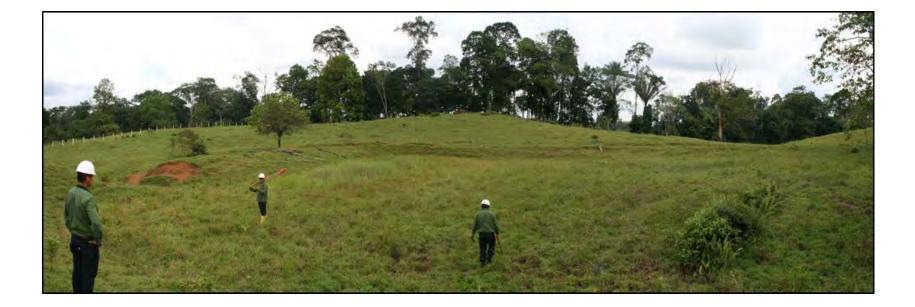
# Photo 30 Pit 3 at SSF-13

Overview of TexPet pit closed in 1976, labeled Pit 3, with PetroEcuador employees examining the pit. View from northwest corner. On the east side of the pit (left in the photo) is a cut in the berm which drains the pit contents to a stream. LBG's soil samples taken outside of this pit's boundary exceeded thresholds by as much as **eight times**.

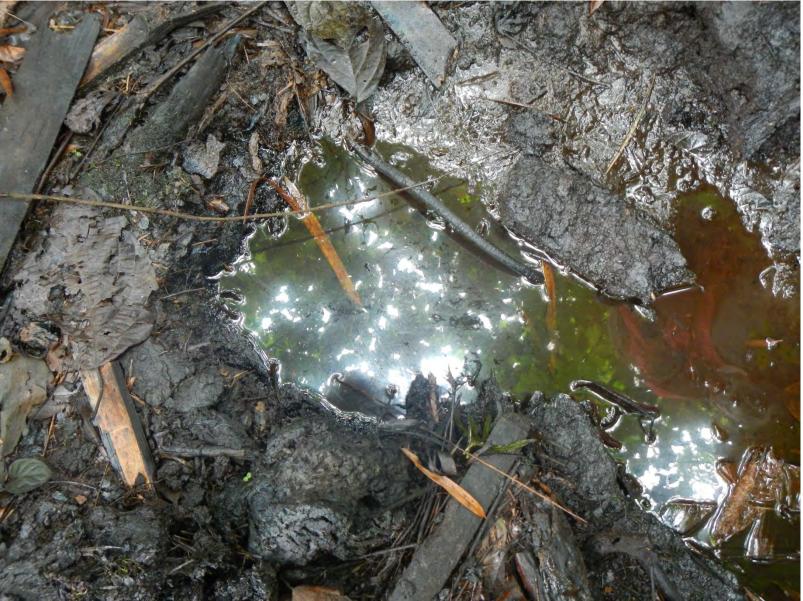
# Photo 36 Oil sheen on sediment and groundwater seep at LA-02

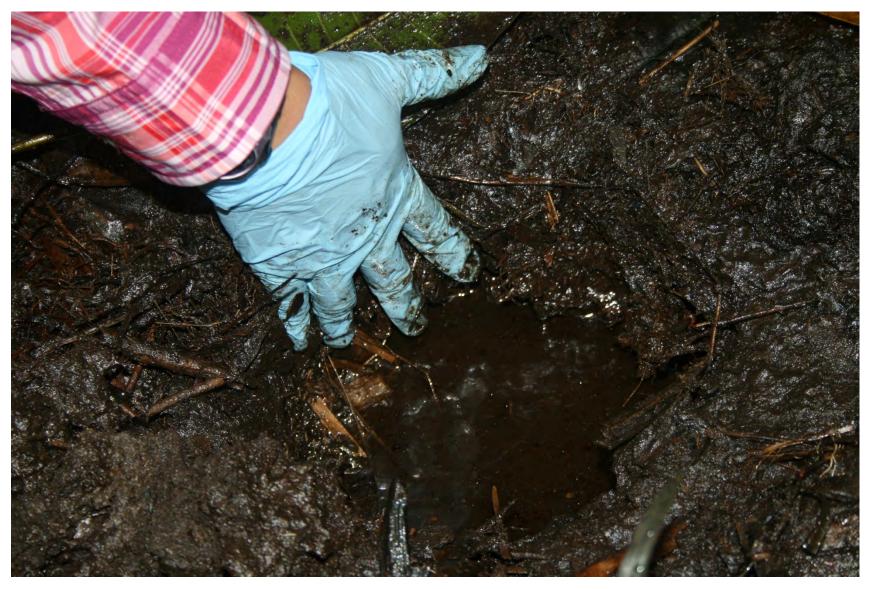
Oil sheen on sediment and groundwater seep at LA-02 with PID reading (10.7 ppm)

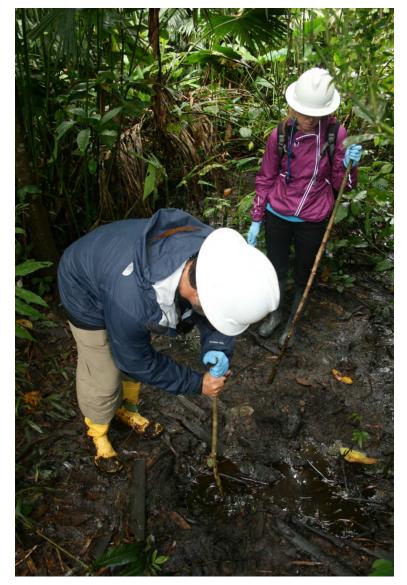
# Photo 40 Oil on stick withdrawn from sediment at LA-02

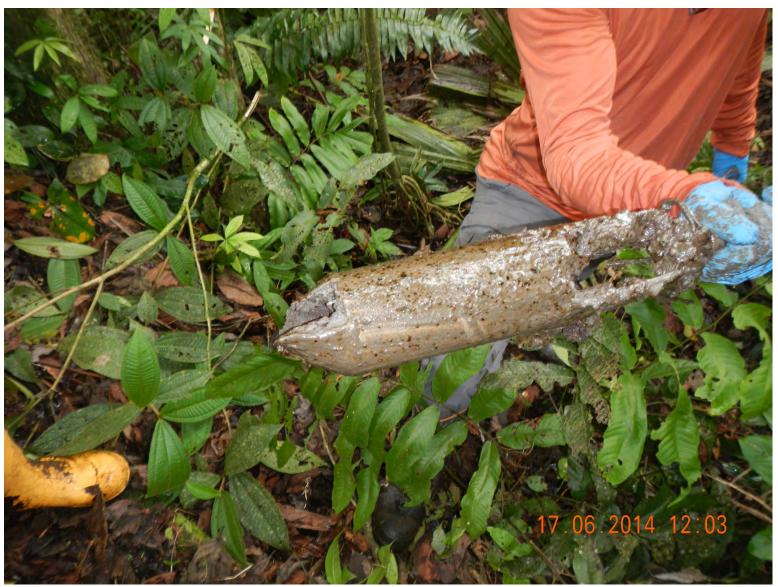
Photo 48 Oil contaminated wetland at SSF-55

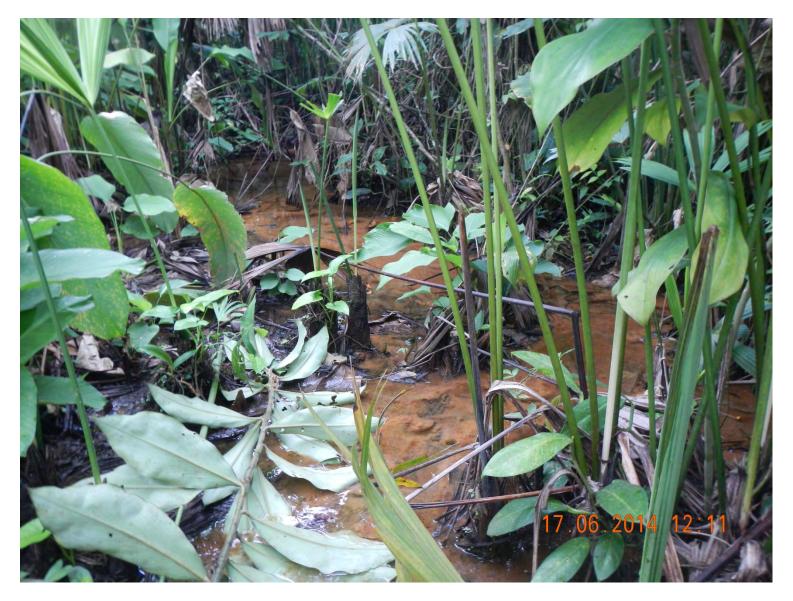
# Photo 49 Petroleum sheen on water in wetland at SSF-25

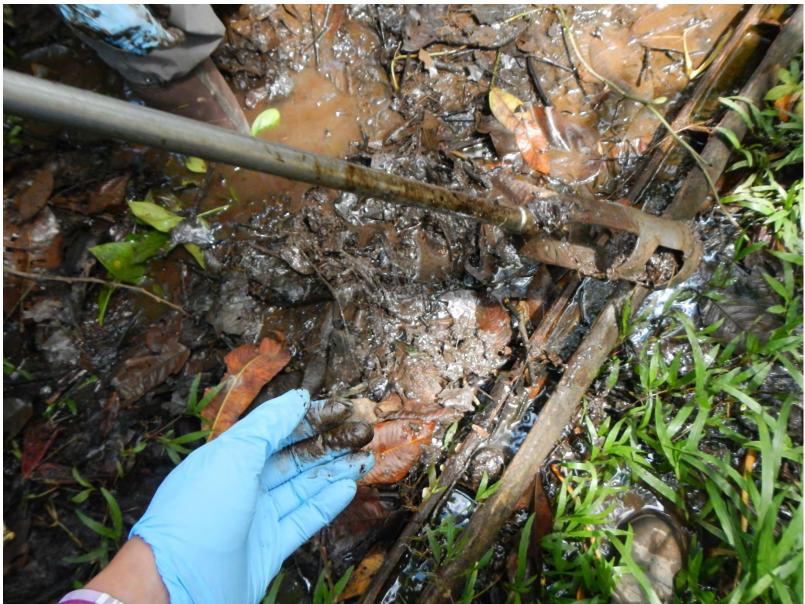
Collecting oil contaminated sediment from stream at SSF-25, note sheens and oil droplets

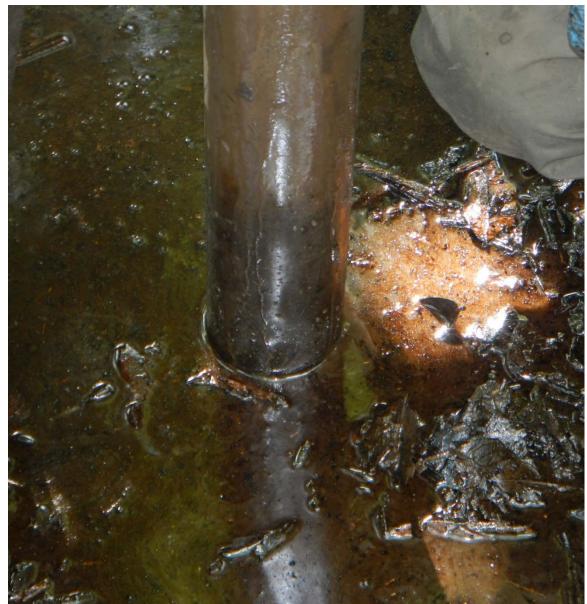
# Photo 52 Asphalt from stream downstream of pit at LA-35

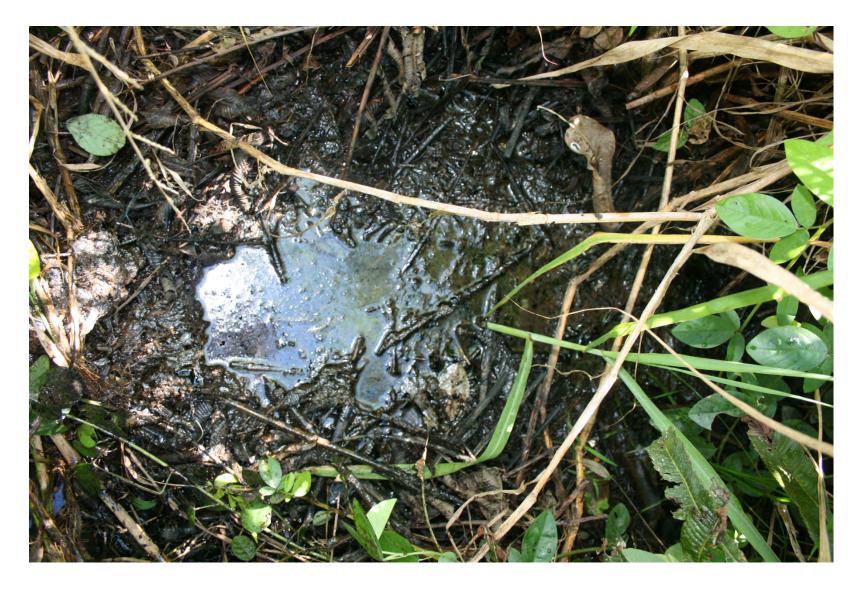
# Photo 55 Petroleum sheen in stream at YU-02

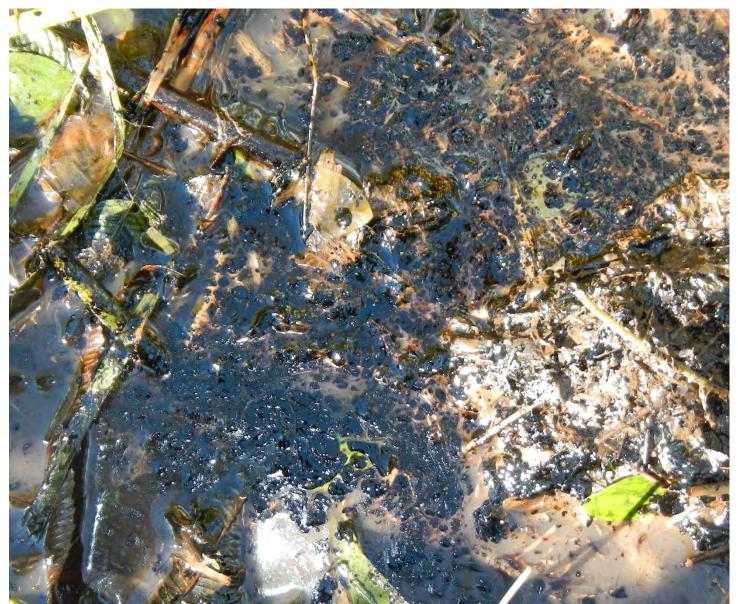
# Photo 57 Oil sheen and droplets on water at YU-02

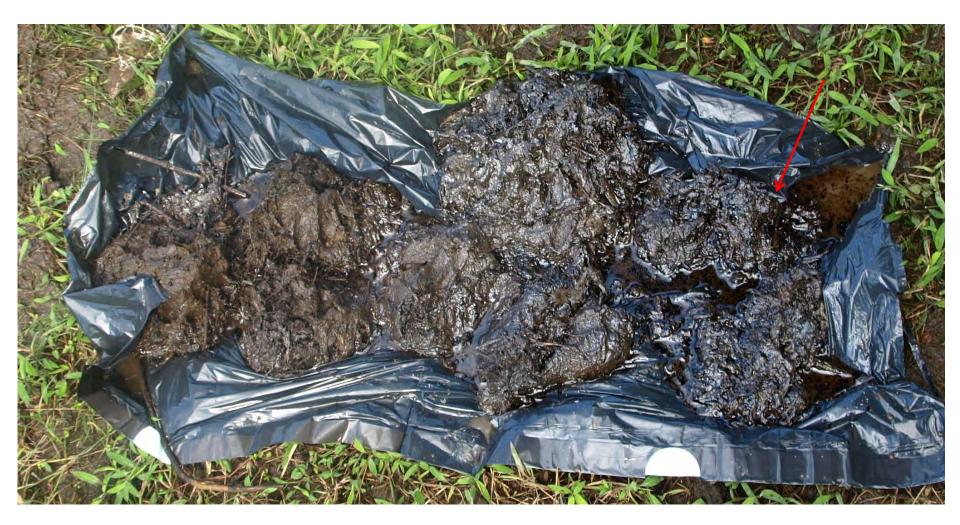
Oil droplets in hand-auger sample of clay from a wetland at YU-02

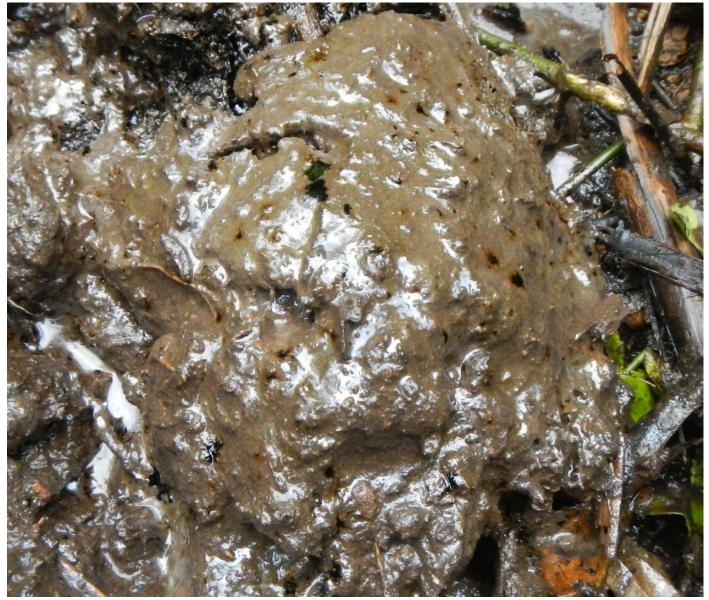
## Petroleum sheen on flowing stream at GU-06, same location as cover photo of the *LBG December 2013 Rejoinder Report*

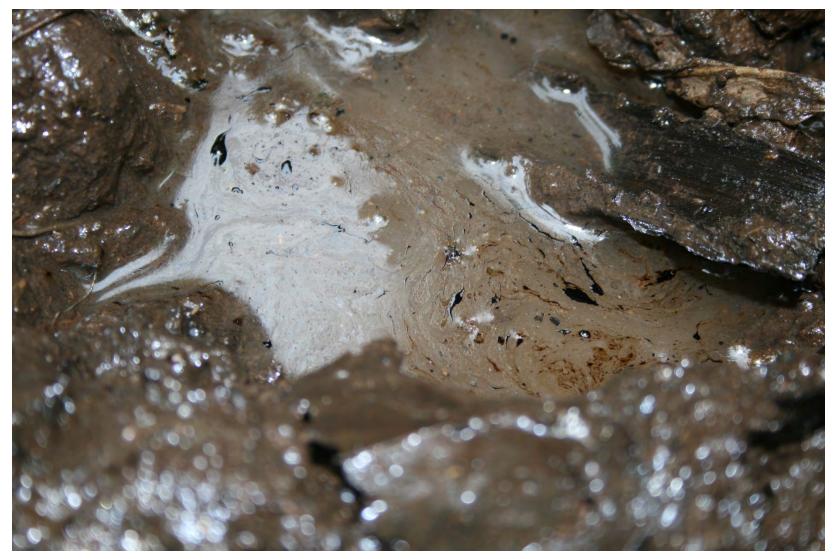
# Photo 68 Sheens in path through oil contaminated wetland at GU-06

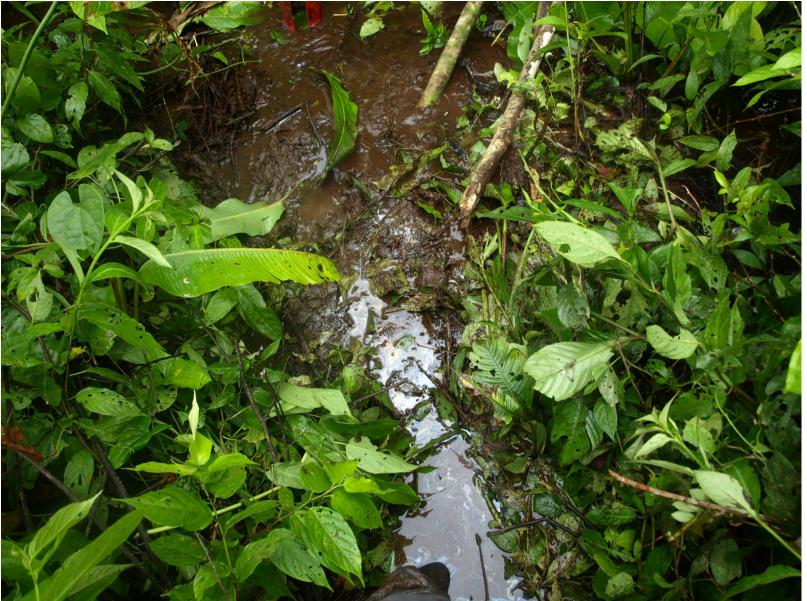
Sheens appearing in footprint just after stepping on the wetland sediment at GU-06

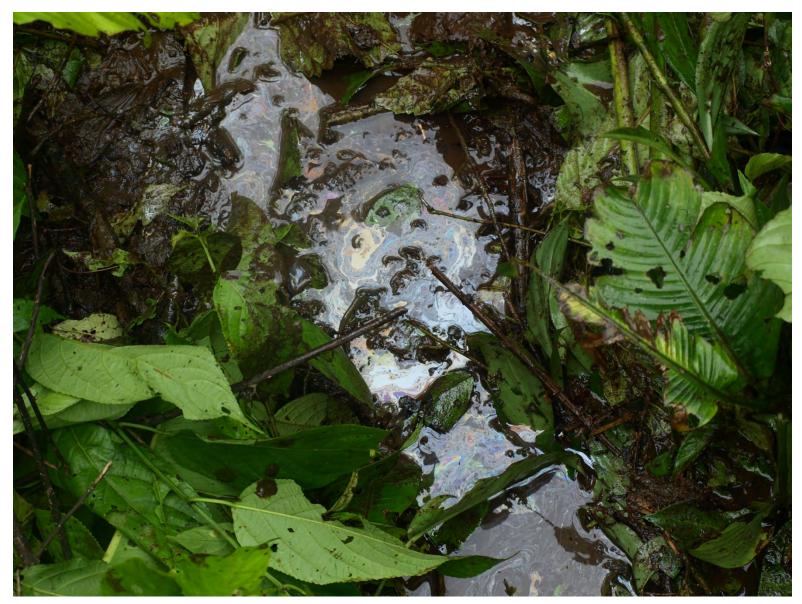
# Photo 70 Petroleum sheen on water at AG-09

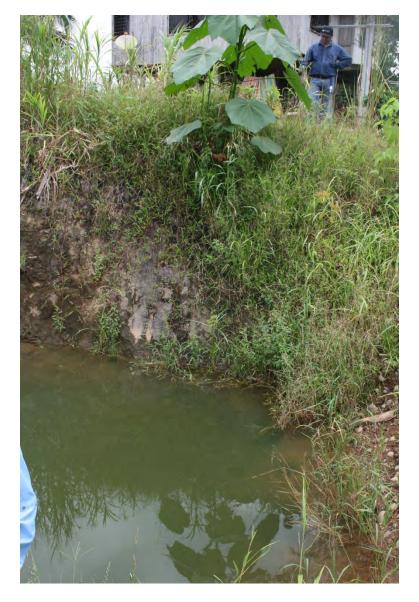
Petroleum in an re-excavated pit during the rain at SA-53; pit was previously remediated during the RAP

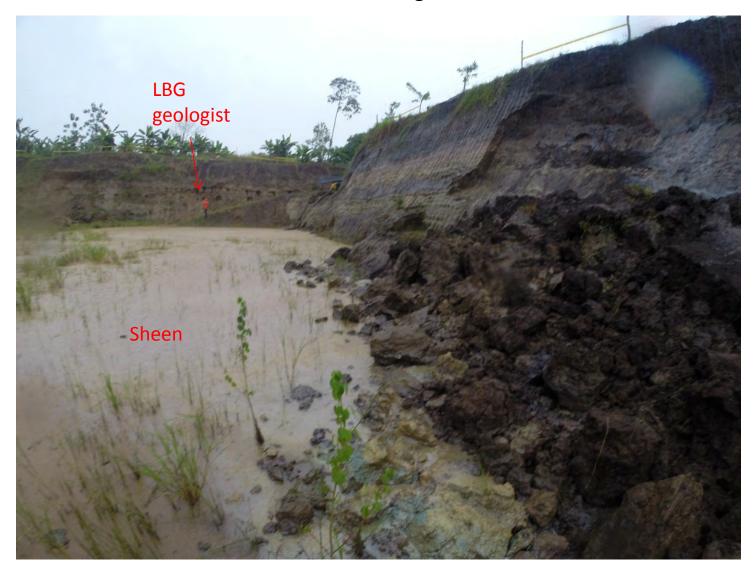
## Petroleum sheen emanating from native soil in excavated pit during rain at SA-53

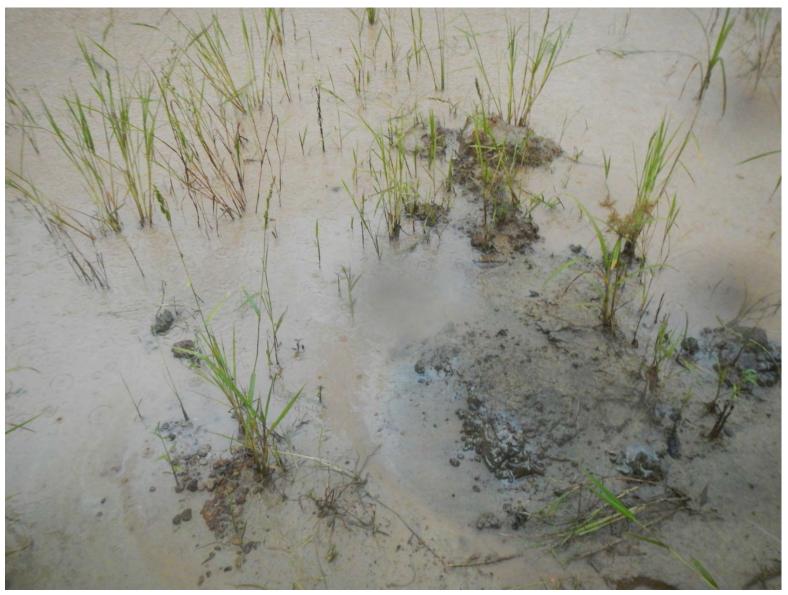
# Ongoing remediation (>3 years) of Texpet "RAP remediated" pit at SA-54; sheen is observable on water

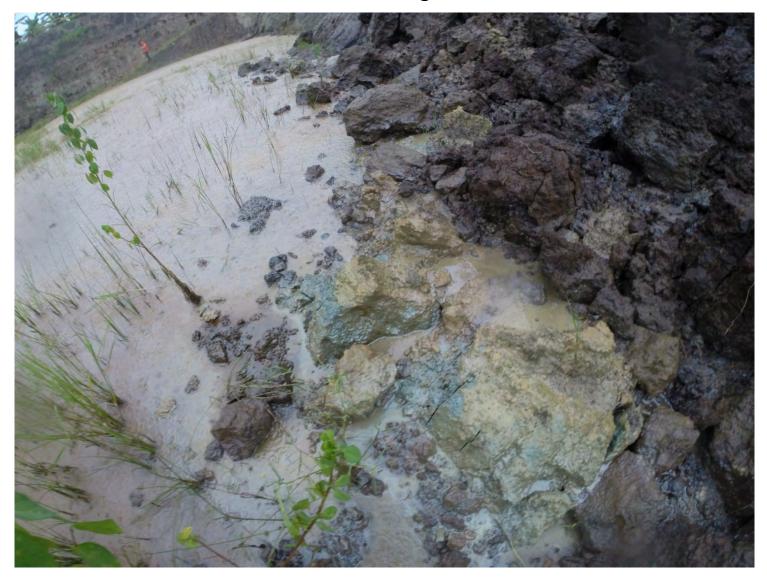
# Photo 86 Ongoing remediation (>3 years) of RAP remediated pit at SA-54

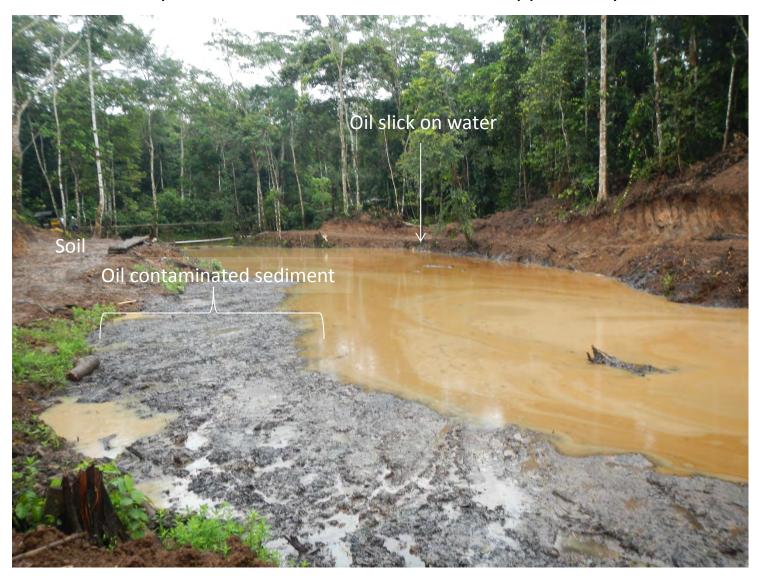
Oil on stream and oil contaminated sediment being remediated at SA-86

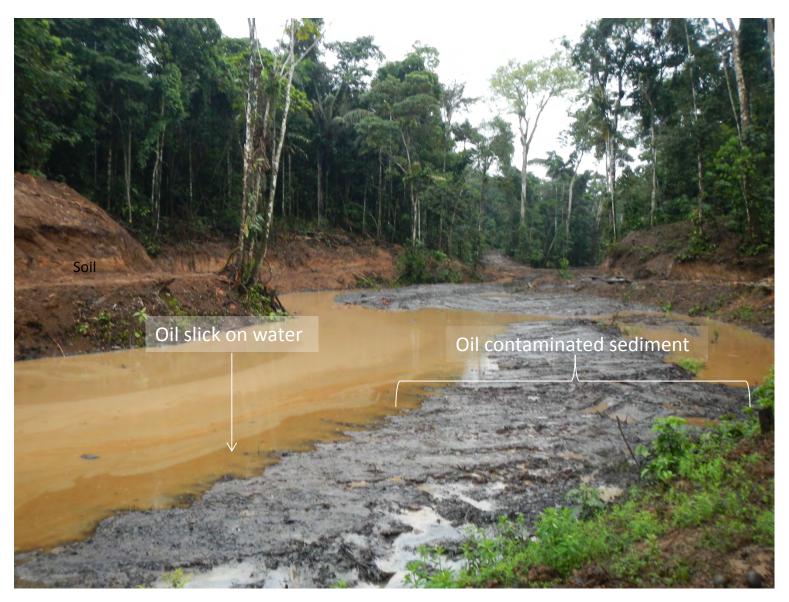
# Stream remediation overview at SA-86. Stream water is diverted to oil-water separators before being discharged downstream

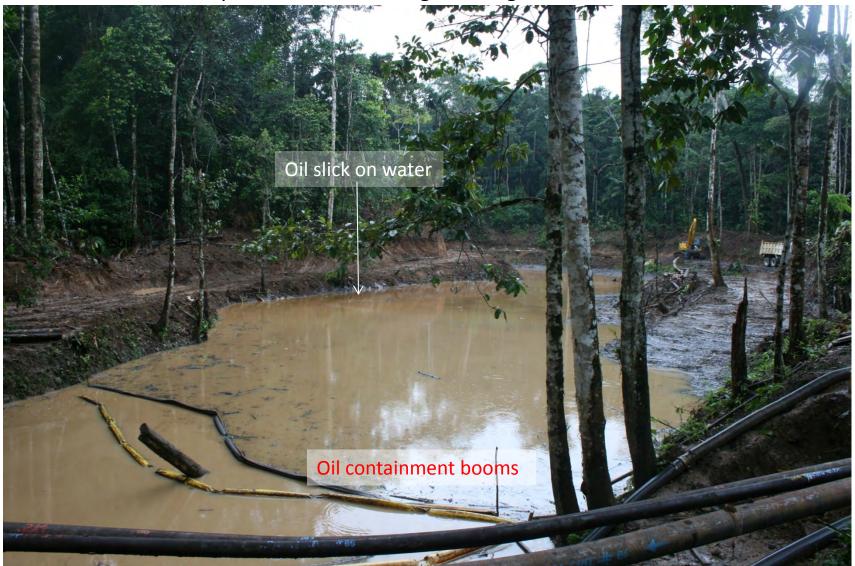
Exposed dark black sediment contains obvious petroleum impacts at SA-86

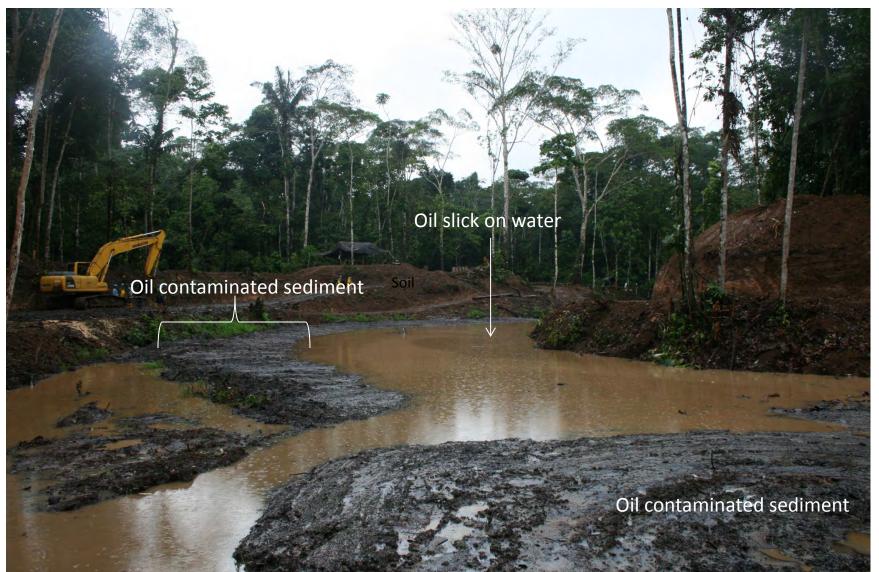
## Photo 92 Looking farther upstream from middle of remediation at SA-86

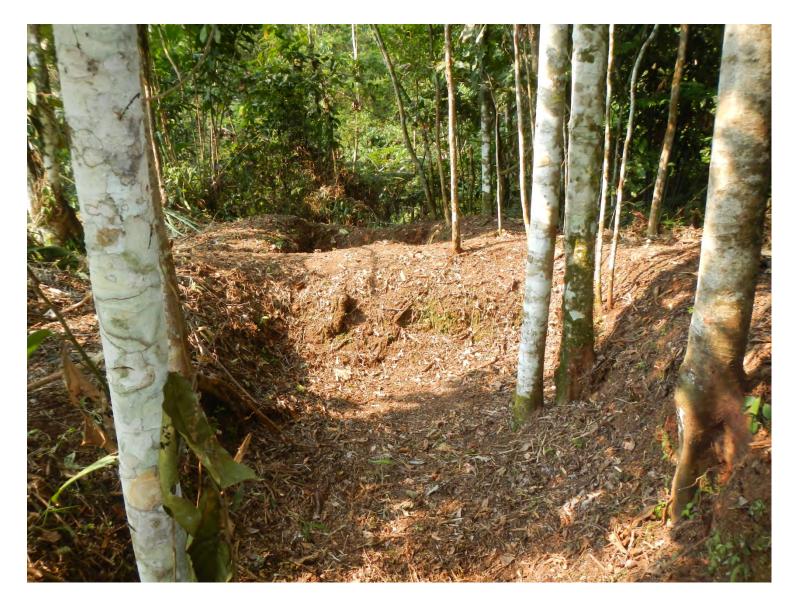
## Photo 103 Soil covered but un-remediated pit at AU-24, next to school

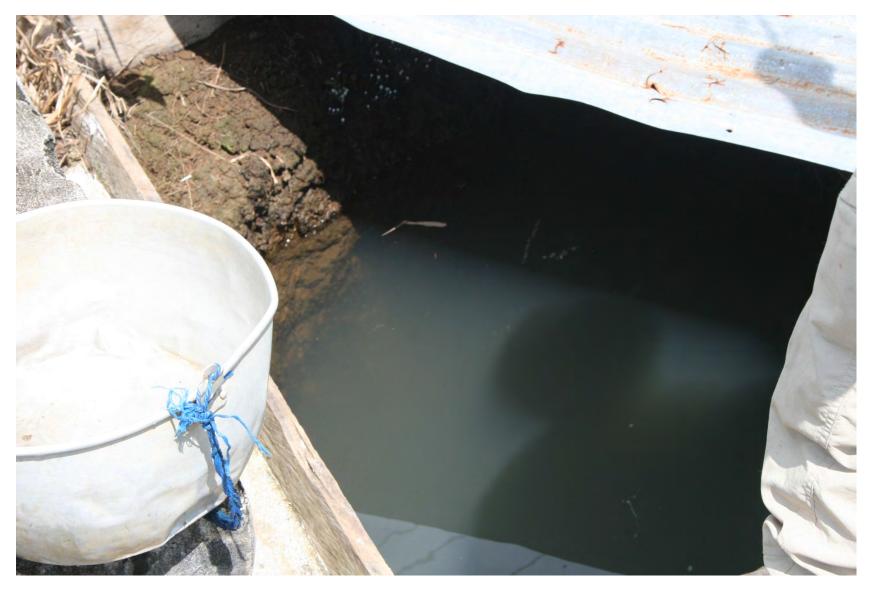
#### Photo 116 Oily groundwater seep at AG-02 – TPH<sub>e8015</sub> analysis of a sediment sample collected here detected 31,310 mg/kg

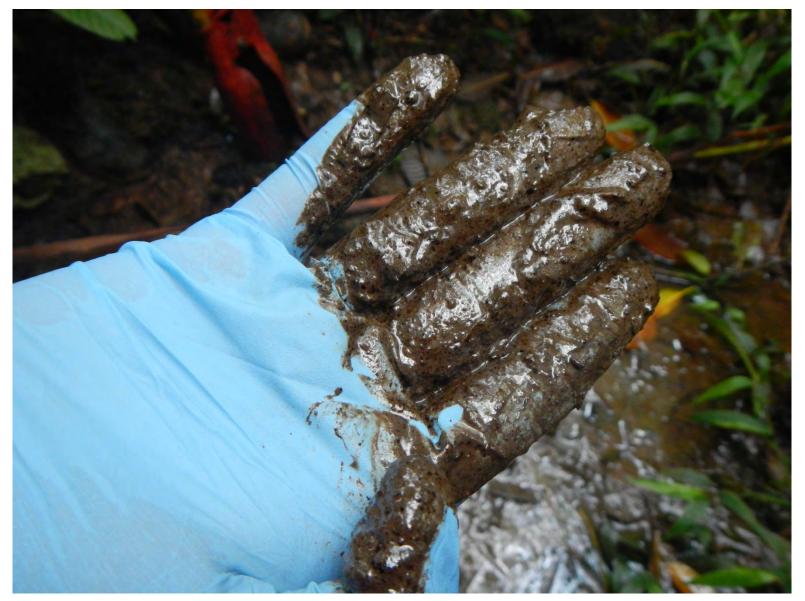
People washing clothes and playing in a stream where petroleum drains at AG-02

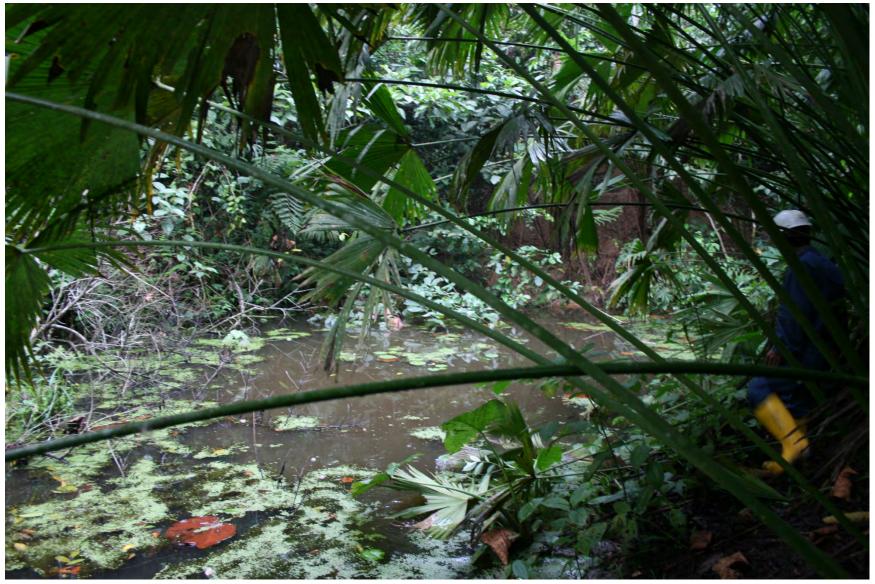
## Photo 123 Unremediated Pit 4 at YU-05

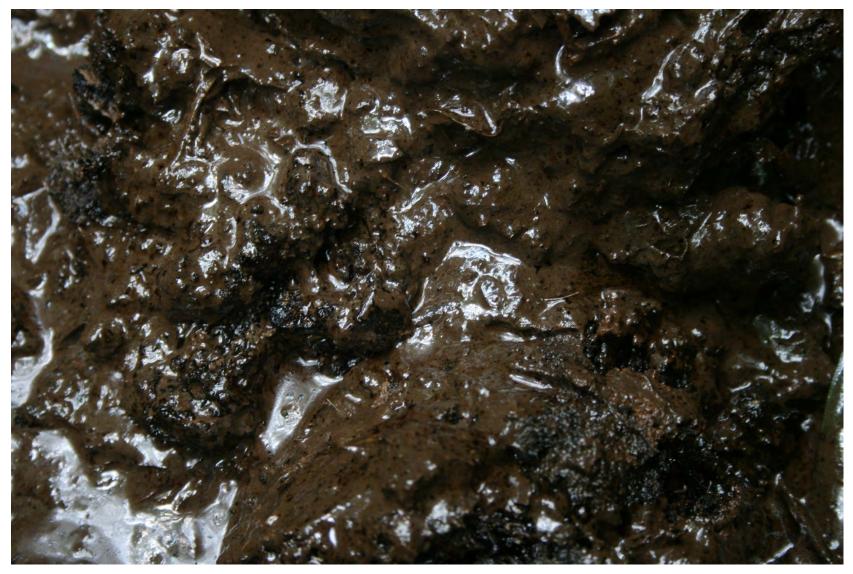
# Photo 132 Oil contaminated sandy sediment in stream at LA-02

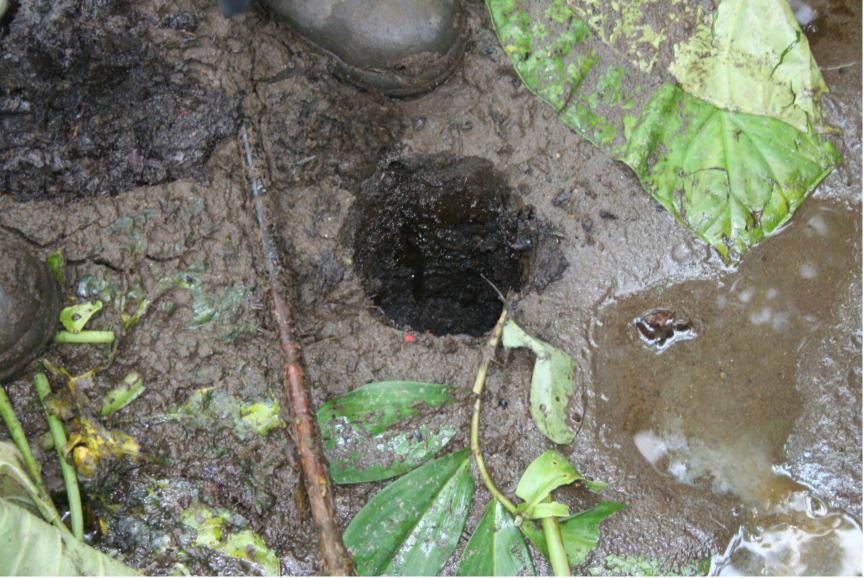
# Photo 133 Small un-remediated pit exposed in sand pit at SA-65

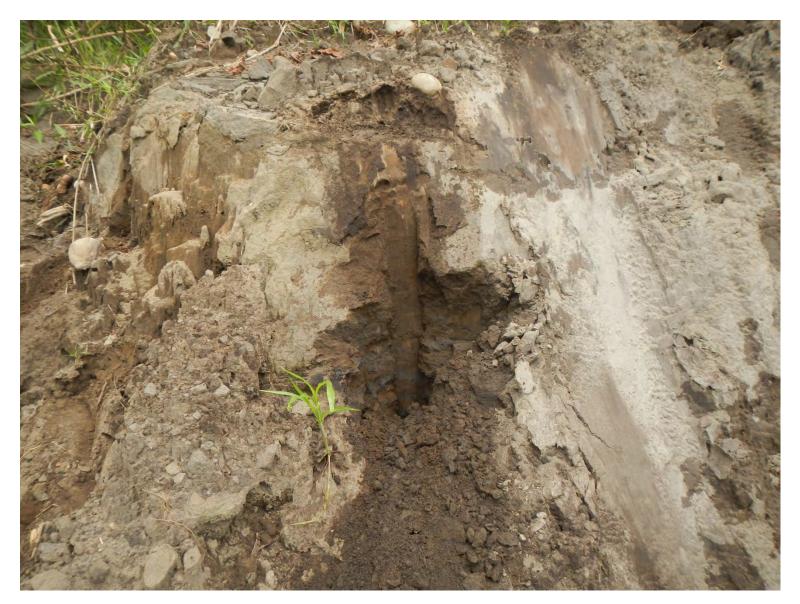
# Photo 135 Sheen emanating from excavated soil at Dureno 01
